**FEDERAL AVIATION ADMINISTRATION
AIRWORTHINESS DIRECTIVES**

**SMALL AIRPLANES, ROTORCRAFT, GLIDERS,
BALLOONS, & AIRSHIPS**

BIWEEKLY 2013-17

8/12/2013 - 8/25/2013

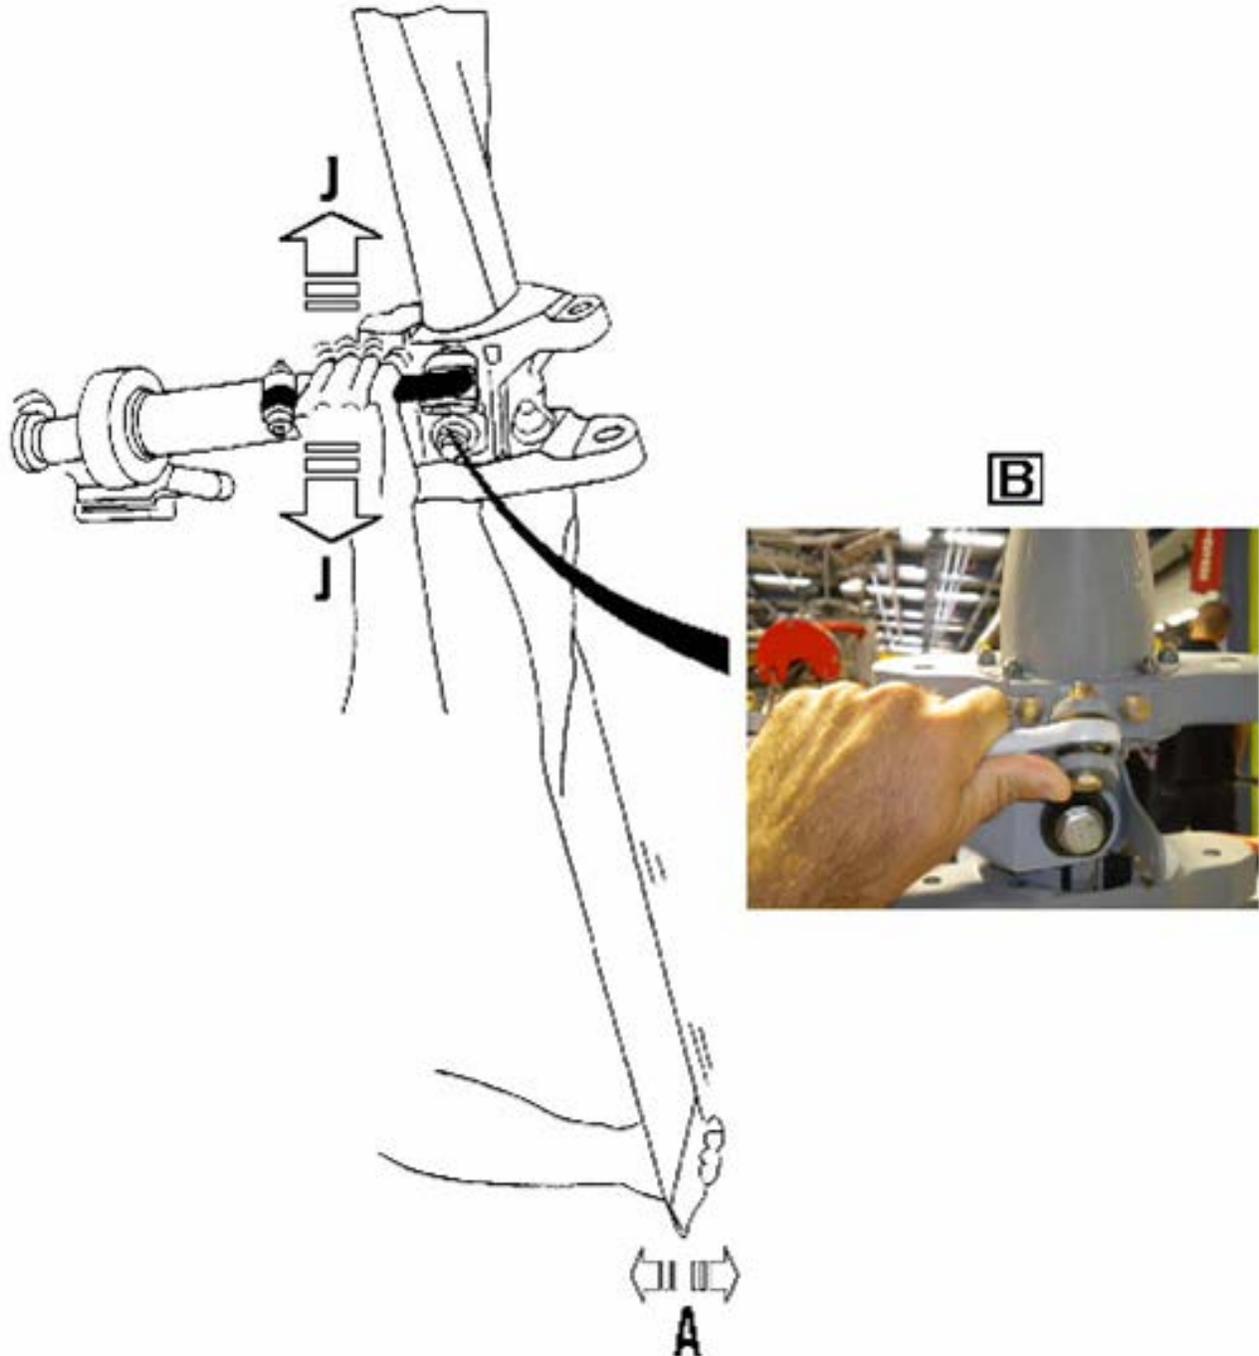
Figure 1: Manual Check for Play of the Tail Rotor Pitch Control Rod

To prevent failure of a T/R control rod, loss of T/R control, and subsequent loss of control of the helicopter, accomplish the following:

(b) If the Teflon cloth is coming out of its normal position within the bearing, totally or partially, or if there is discoloration or scoring on the bearing, before further flight, replace the control rod with an airworthy control rod.

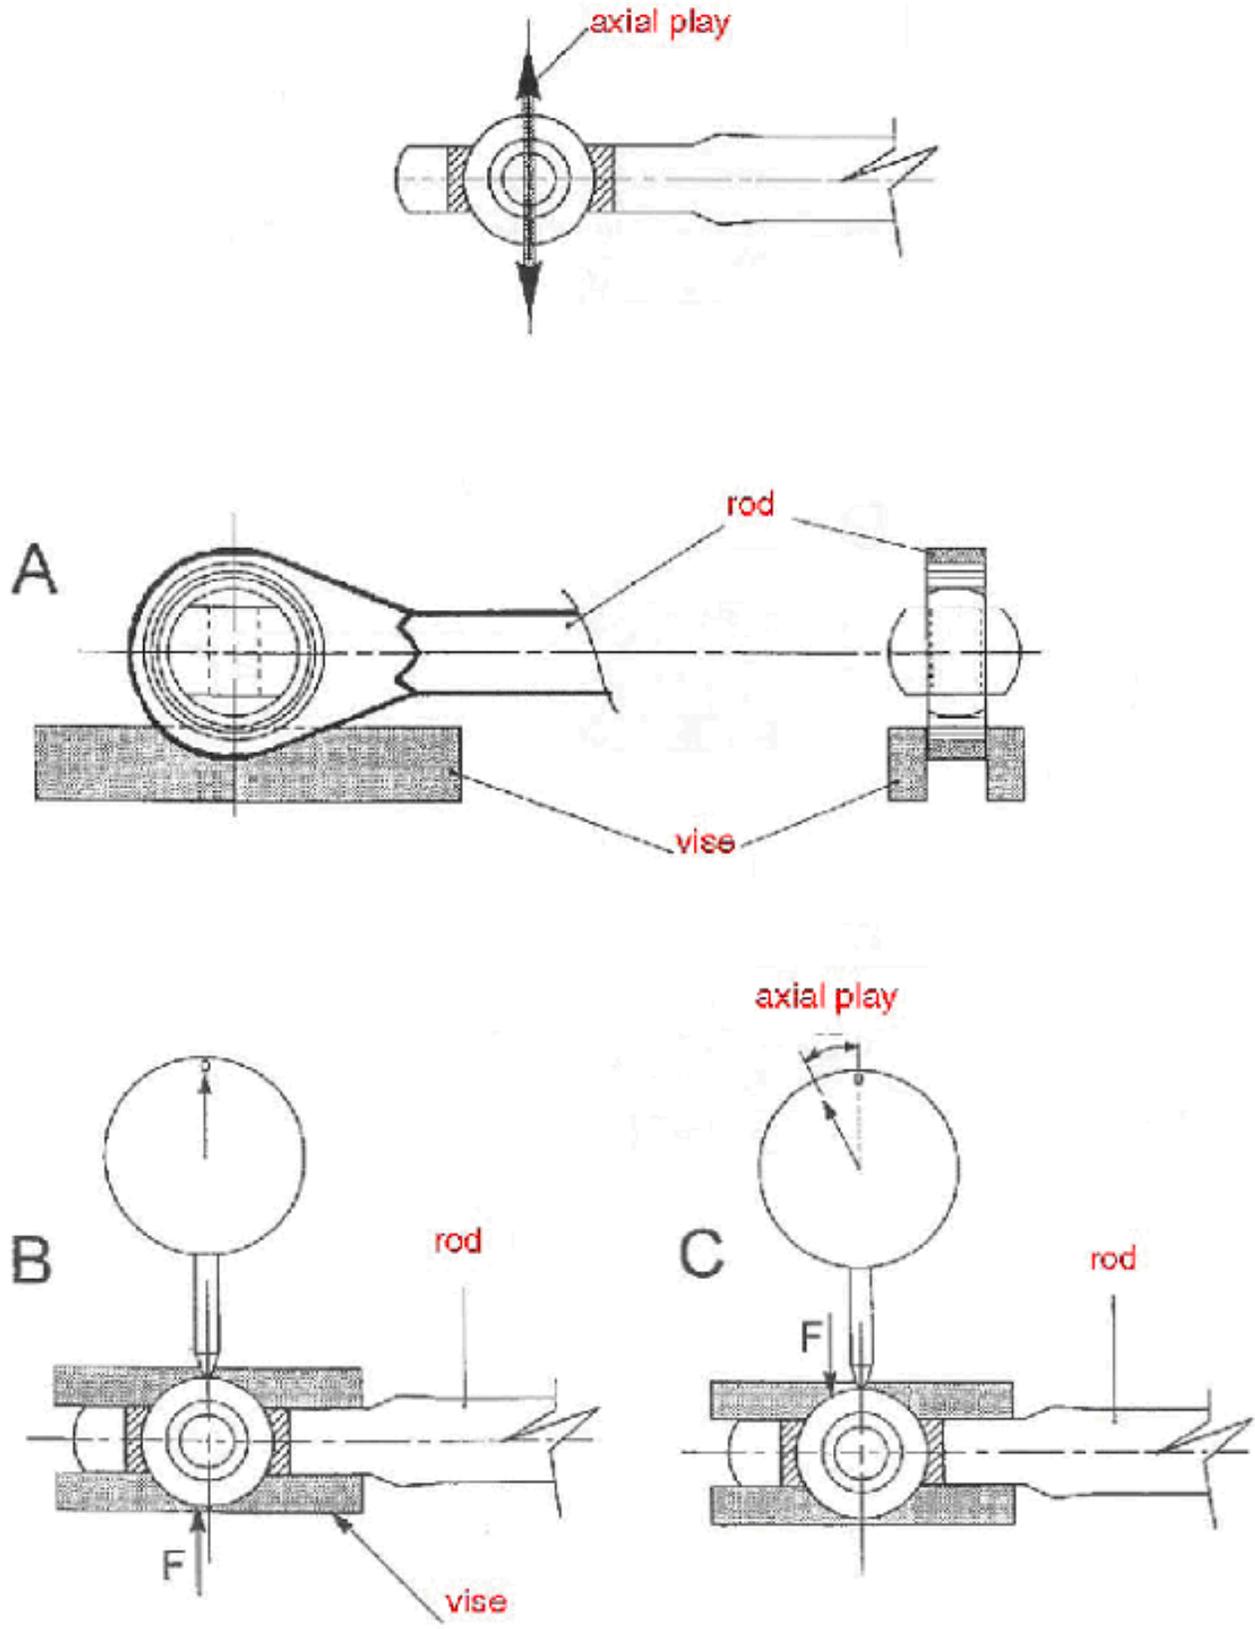
Figure 2: Measurement of the Axial Play (A) of the Bearing

(c) If a pilot or mechanic detects play, a mechanic must remove the control rod from the helicopter, and using a dial indicator, measure the bearing wear according to the following and as shown in Figures 2 and 3 of this AD:

- (1) Remove the control rod from the helicopter.
 - (2) Mount the control rod in a vise as shown in Figure 2 of this AD.
 - (3) Using a dial indicator, take axial play readings by moving the spherical bearing in the direction F (up and down) as shown in Figure 2 of this AD.

- (8) If the radial play exceeds 0.008 inch or axial play exceeds 0.016 inch, replace the control rod with an airworthy control rod before further flight.

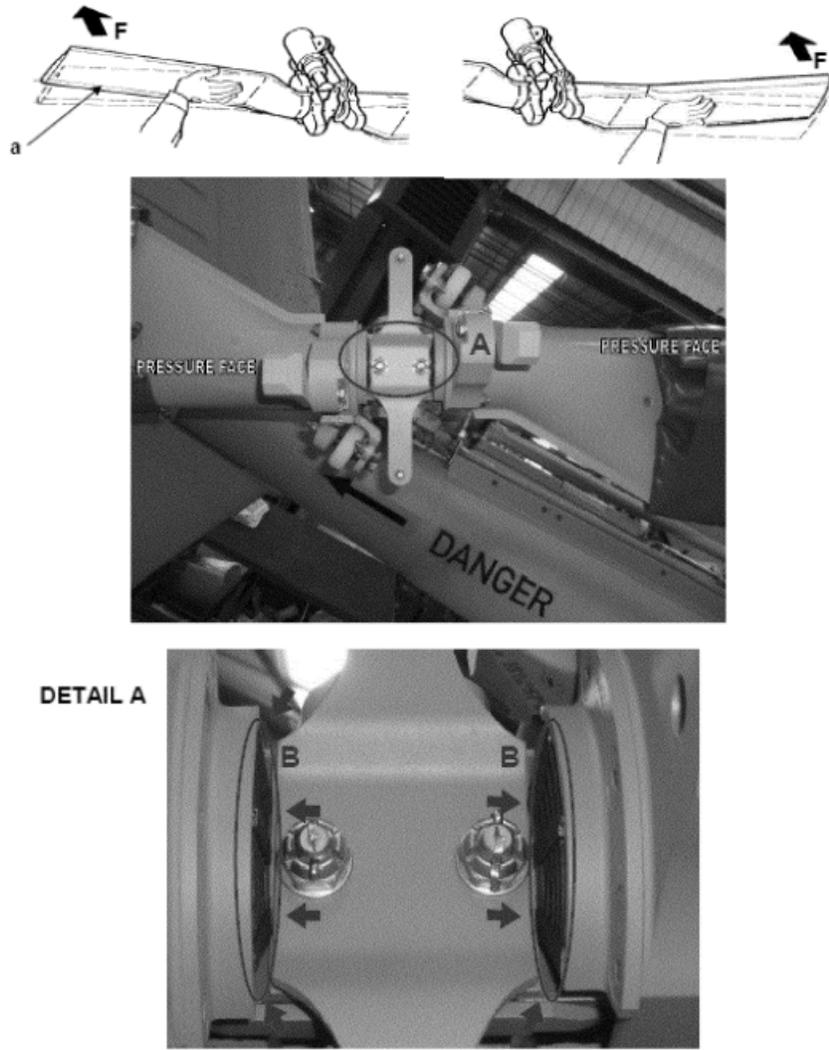
This AD defines the unsafe condition as severe vibrations due to failure of laminated half-bearings (bearings). This condition could result in failure of the tail rotor and subsequent loss of control of the helicopter.

(ii) Apply load (F) by hand, perpendicular to the pressure face of one tail rotor blade (a), as shown in Figure 1 to paragraph (f) of this AD, taking care not to reach the extreme position against the tail rotor hub. The load will deflect the tail rotor blade towards the tail boom.

(iii) While maintaining the load, check all the visible faces of the bearings (front and side faces) in area B of DETAIL A of Figure 1 to paragraph (f) of this AD for separation between the elastomer and metal parts, a crack in the elastomer, or an extrusion (see example in Figure 2 to paragraph (f) of this AD). A flashlight may be used to enhance the check.

(5) If there is an extrusion on any bearing, before further flight, replace the four bearings with airworthy bearings.

(6) If there is a separation or a crack on the pressure side bearing, measure the separation or the crack. If the separation or crack is greater than 5 millimeters (.196 inches) as indicated by dimension "L" in Figure 4 to paragraph (f), before further flight, replace the four bearings with airworthy bearings.

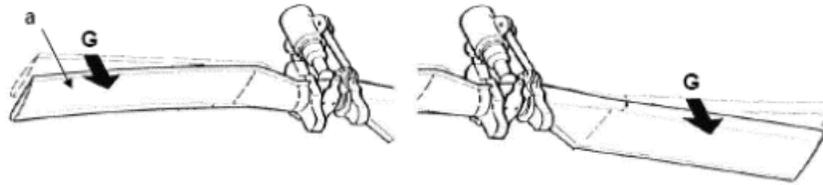
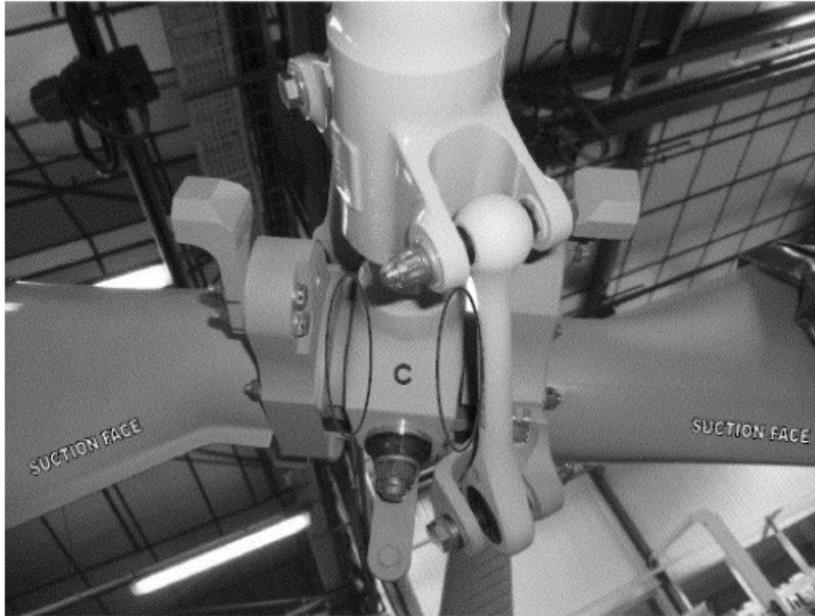
(vi) While maintaining the load, check visible faces of Area C as shown in Figure 3 to paragraph (f) of this AD for any extrusion. A flashlight may be used to enhance the check.
