**FEDERAL AVIATION ADMINISTRATION  
AIRWORTHINESS DIRECTIVES**

**SMALL AIRPLANES, ROTORCRAFT, GLIDERS,  
BALLOONS, & AIRSHIPS**

**BIWEEKLY 2013-26**

*12/16/2013 - 12/29/2013*

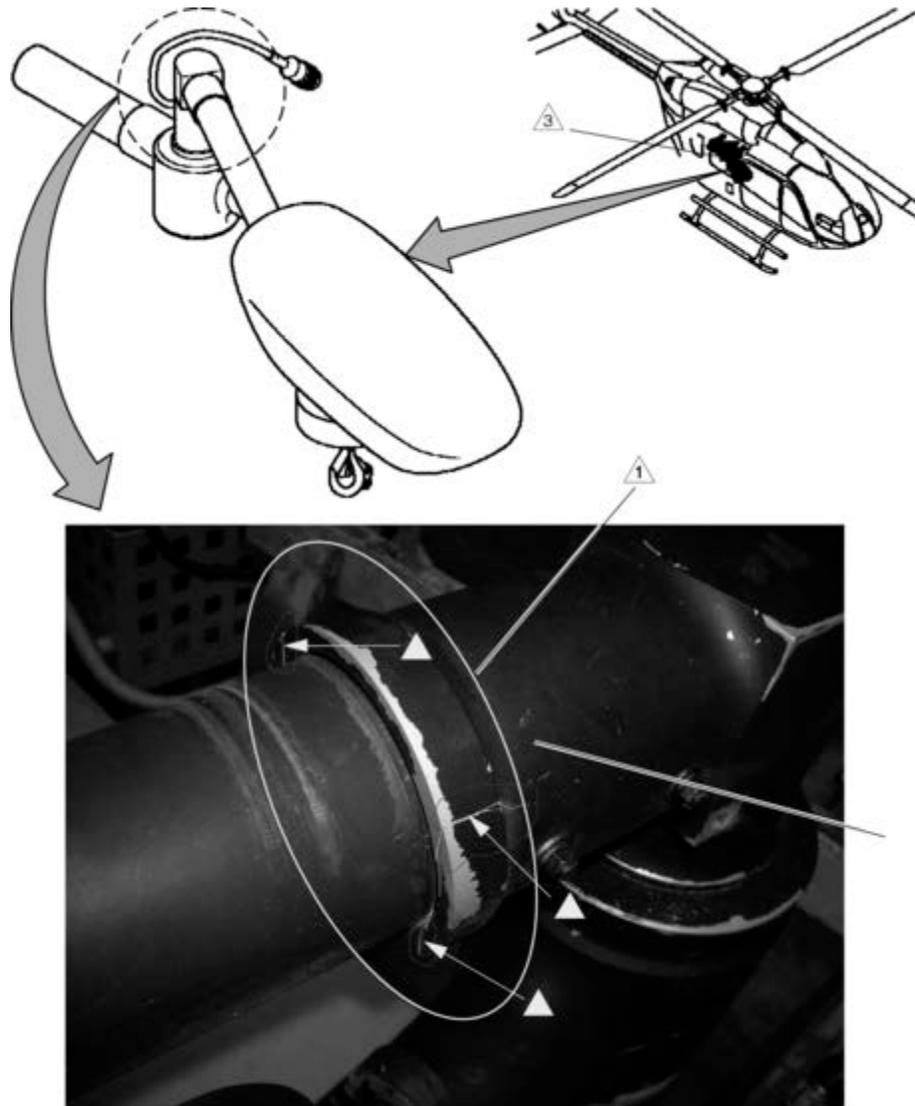
Figure 1 to Paragraph (e)

This AD defines the unsafe condition as a crack in the boom. This condition could result in loss of the boom and attached loads, and subsequent loss of helicopter control.

(1) Before further flight, and thereafter before the first flight of each day until you have performed the inspection required by paragraph (e)(2) of this AD, clean the hoist and visually check for a crack, paying particular attention to the areas that are circled as depicted in Figure 1 to paragraph (e) of this AD. The actions required by this paragraph may be performed by the owner/operator (pilot) holding at least a private pilot certificate, and must be entered into the aircraft records showing compliance with this AD in accordance with 14 CFR 43.9(a)(1)-(4) and 14 CFR 91.417(a)(2)(v). The record must be maintained as required by 14 CFR 91.417, 121.380, or 135.439.

(2) Within 30 days, perform a dye penetrant inspection of the boom in accordance with the Accomplishment Instructions, Section 2.D, of the Goodrich Service Bulletin 44307-500-03, Revision 2, dated April 30, 2010 (SB).

(3) If a crack exists in the boom, replace the cracked boom with an airworthy boom before further flight.

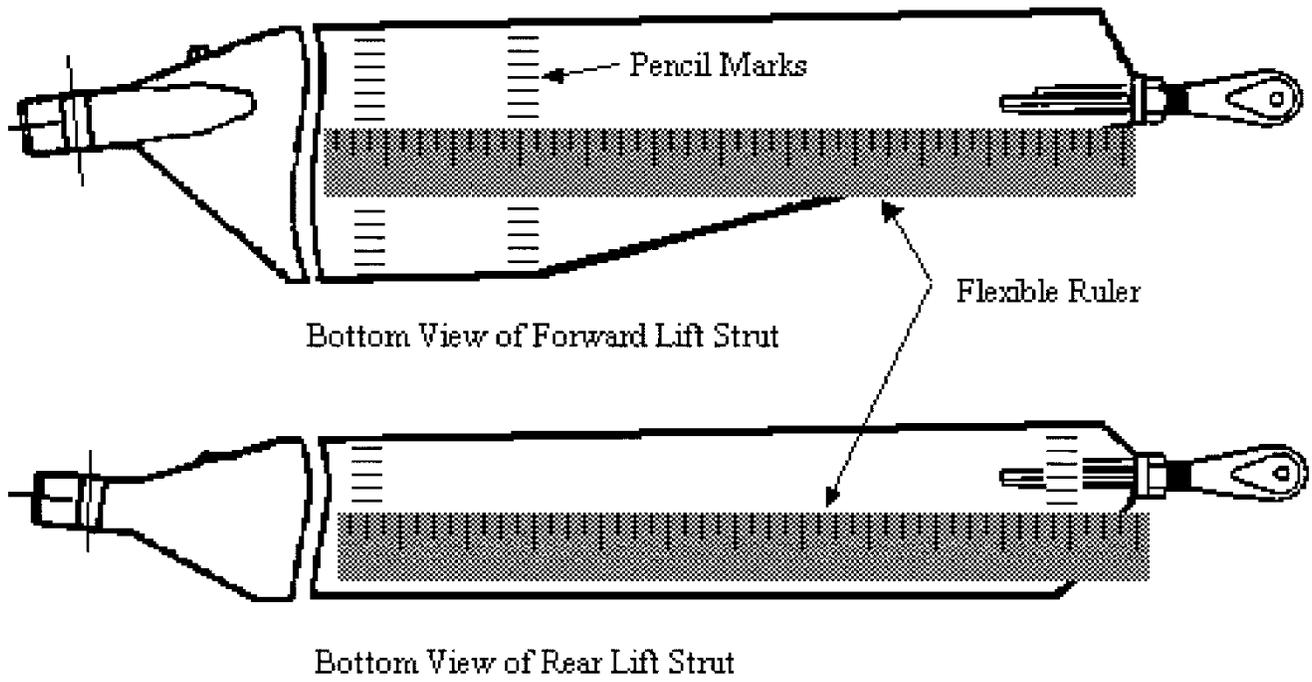
**Figure 1**

(3) We are issuing this AD to detect and correct corrosion on the front and rear wing lift struts, which could cause the wing lift strut to fail. This failure could result in the wing separating from the airplane.

8. A measurement of 0.024 inch or less shall require replacement of the strut prior to further flight.

9. If at any time during testing an area is encountered where a valid thickness measurement cannot be obtained due to a loss of signal strength or quality, the area shall be considered suspect. These areas may have a remaining wall thickness of less than 0.020-inch, which is below the range of this setup, or they may have small areas of localized corrosion or pitting present. The latter case will result in a reduction in signal strength due to the sound being scattered from the rough surface and may result in a signal that includes echoes from the pits as well as the backwall. The suspect area(s) shall be tested with a Maule "Fabric Tester" as specified in Maule Air, Inc. Service Bulletin No. 11, dated October 30, 1995.

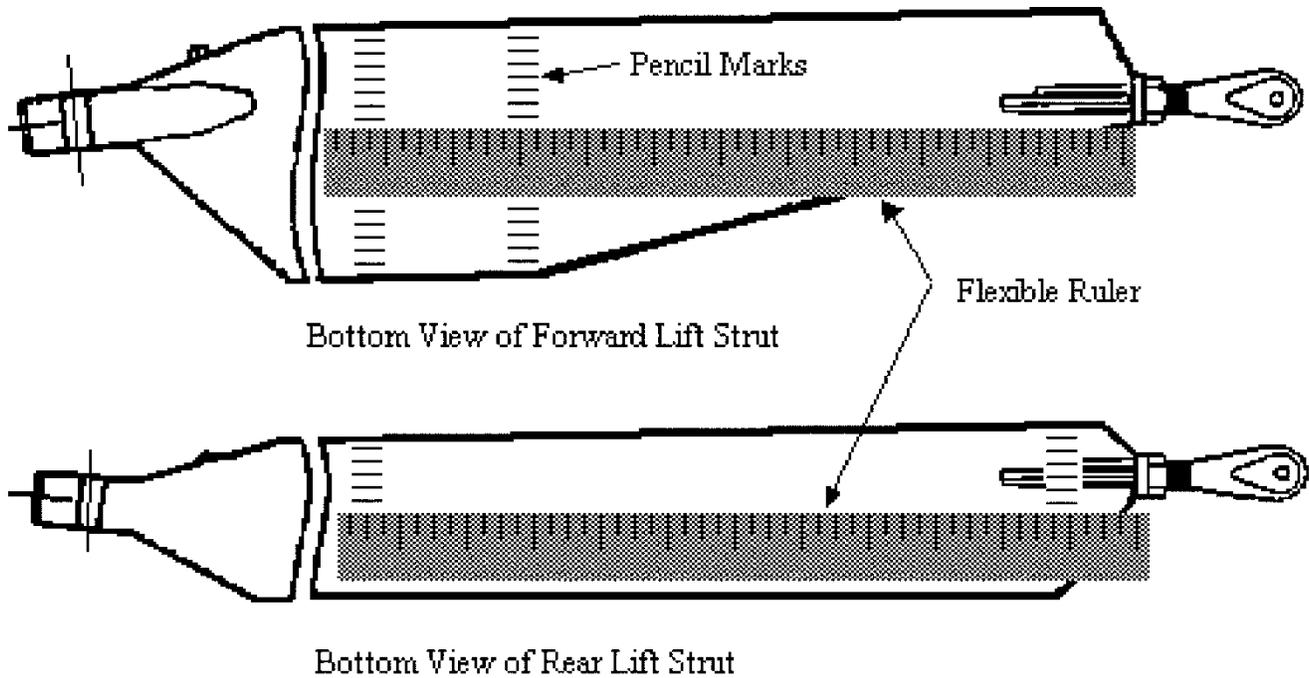
**Figure 1**

(3) We are issuing this AD to detect and correct corrosion and cracking on the front and rear wing lift struts and forks, which could cause the wing lift strut to fail. This failure could result in the wing separating from the airplane.

9. If at any time during testing an area is encountered where a valid thickness measurement cannot be obtained due to a loss of signal strength or quality, the area shall be considered suspect. These areas may have a remaining wall thickness of less than 0.020-inch, which is below the range of this setup, or they may have small areas of localized corrosion or pitting present. The latter case will result in a reduction in signal strength due to the sound being scattered from the rough surface and may result in a signal that includes echoes from the pits as well as the backwall. The suspect area(s) shall be tested with a Maule "Fabric Tester" as specified in Piper SB No. 528D, dated October 19, 1990, or Piper SB No. 910A, dated October 10, 1989.
