**FEDERAL AVIATION ADMINISTRATION
AIRWORTHINESS DIRECTIVES**

LARGE AIRCRAFT

BIWEEKLY 2018-19

9/3/2018 - 9/16/2018

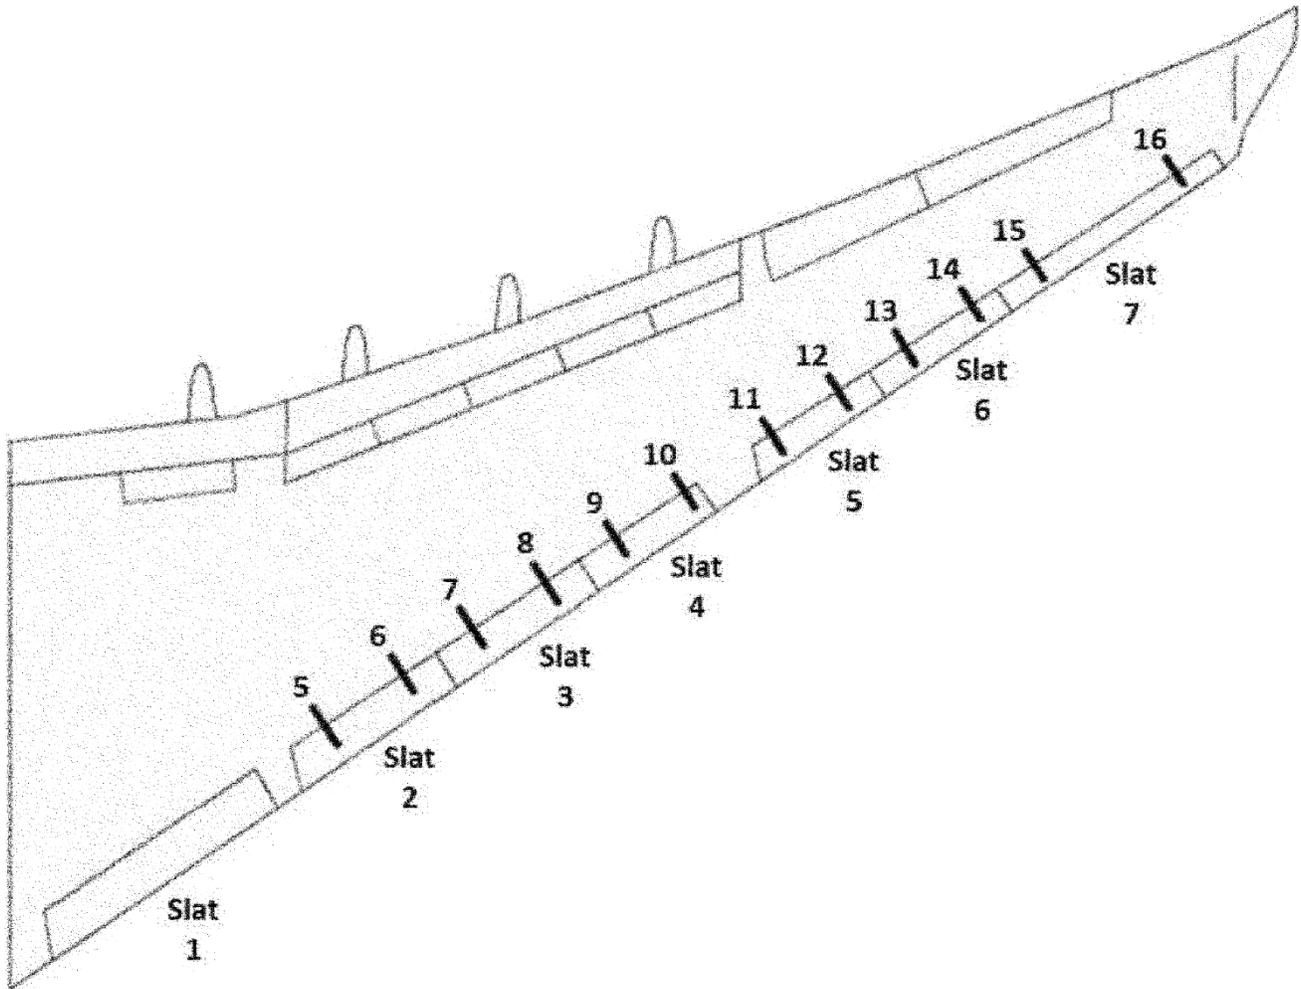
Figure 1 to paragraph (g) of this AD – Positions of Affected Slat Tracks

This AD was prompted by reports of cracked slat tracks at the location of the front stop attachment to the track. We are issuing this AD to detect and correct cracked slat tracks which could affect the structural integrity of the slat surface, possibly leading to detachment of an outer or inner slat surface, and resulting in reduced control of the airplane.

(1) For the purpose of this AD, “affected slat track” is defined as a pre-modification 45967 slat track, located at the wing positions as indicated in figure 1 to paragraph (g) of this AD, and having a part number specified in figure 2 to paragraph (g) of this AD. In case the part number identification (ID) plate is missing or cannot be read, the slat track can be identified by the ink marking. If the operator cannot determine the part number, then that airplane is in Group 1.

(1) If, during any special detailed inspection required by paragraph (h) of this AD, any crack is detected at the front stop attachment area of an affected slat track: Before further flight, obtain corrective action instructions approved by the Manager, International Section, Transport Standards Branch, FAA; or the European Aviation Safety Agency (EASA); or Airbus SAS's EASA Design Organization Approval (DOA), and accomplish them within the compliance time specified therein. If approved by the DOA, the approval must include the DOA-authorized signature.

(2) If, during any inspection required by paragraph (h) of this AD, marks (dents or scratches) are found on the front stop lateral or aft surfaces of an affected slat track; provided that no crack is detected; before further flight, rework the affected lateral front stop surface of that slat track, and accomplish slat rigging, as applicable, in accordance with the Accomplishment Instructions of Airbus Service Bulletin A330-57-3123, Revision 01, including Appendixes 02 and 03, dated September 27, 2017; or Airbus Service Bulletin A340-57-4130, Revision 01, including Appendixes 02 and 03, dated September 27, 2017. Accomplishment of rework or slat rigging on an airplane, as required by this

(1) Replacement of an affected slat track at any position with a post-modification 45967 slat track, if accomplished as part of the corrective actions specified in paragraph (i)(1) or (i)(3) of this AD, terminates the repetitive inspections required by paragraph (h) of this AD, for that slat track position.
