**FEDERAL AVIATION ADMINISTRATION  
AIRWORTHINESS DIRECTIVES**

**SMALL AIRPLANES, ROTORCRAFT, GLIDERS,  
BALLOONS, & AIRSHIPS**

**BIWEEKLY 2017-09**

*4/17/2017 - 4/30/2017*

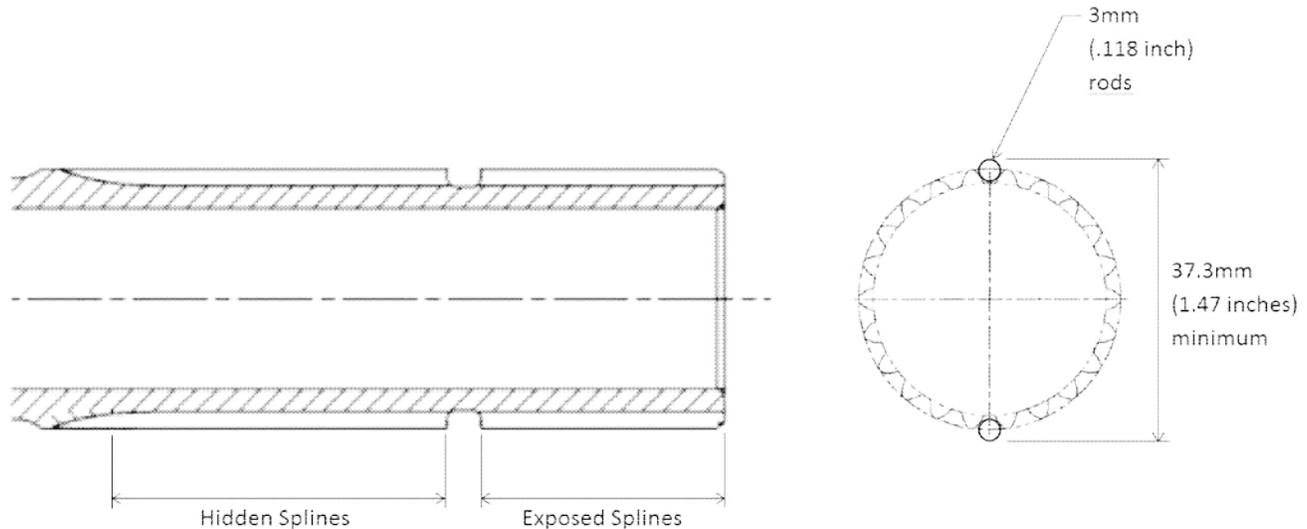
(ii) Inspect the exposed portion of each wheel spline for cracking, scoring, metal pick-up, and wear by using Figure 1 to paragraph (f)(1)(ii) of this AD. To inspect for wear, position two 3 mm (0.118 inch) rods in all diametrically opposed splines and measure to determine whether there is a

minimum of 37.3 mm (1.47 inches) across the outside diameter of the rods. If there is any cracking, scoring or metal pick-up, or if a measurement is less than 37.3 mm, replace the wheel.
