**FEDERAL AVIATION ADMINISTRATION  
AIRWORTHINESS DIRECTIVES**

**SMALL AIRPLANES, ROTORCRAFT, GLIDERS,  
BALLOONS, & AIRSHIPS**

**BIWEEKLY 2018-03**

*1/22/2018 - 2/4/2018*

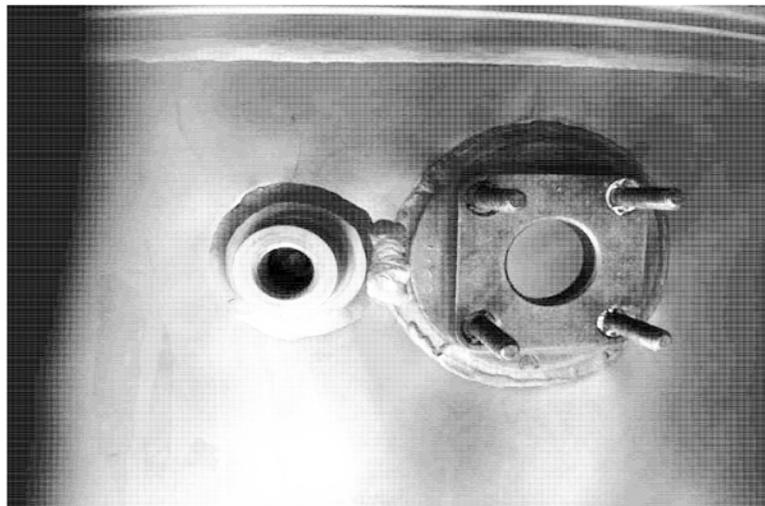
**Figure 1 to Paragraph (h) of this AD. Combustion Chamber Case Assembly**

TPE331 model engines modified by STC SE383CH may be defined as the “Super 1” and “Super 2” for the compressor modification of the TPE331-1 and the TPE331-2, -2U, and -2UA engines, respectively. Figures 1 and 2 to paragraph (h) of this AD illustrate the appearance of combustion chamber case assembly, P/N 893973-5, without and with, respectively, the one-piece bleed pad with the P3 boss.

**Without the One-Piece Bleed Pad with P3 Boss**

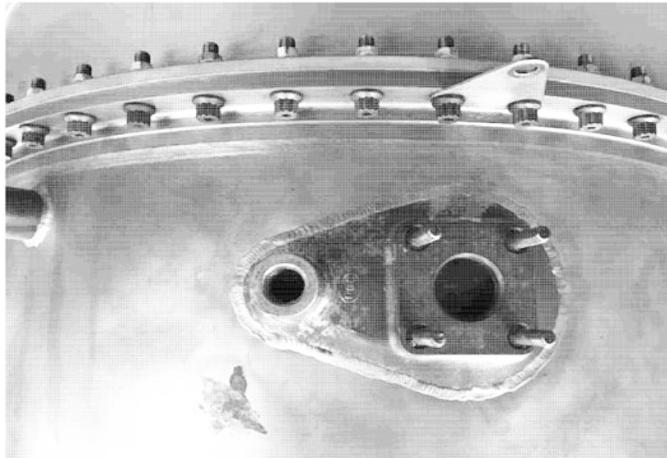
Figure 2 to Paragraph (h) of this AD. Combustion Chamber Case Assembly with  
One-Piece Bleed Pad with P3 Boss

After the effective date of this AD, do not install a combustion chamber case assembly, P/N 869728-1, 869728-3, or 893973-5, in TPE331-3U, -3UW, -5, -5A, -5AB, -5B, -6, and -6A engines or in TPE331-1, -2, and -2UA engines modified by National Flight Services, Inc., STC SE383CH, unless the combustion chamber case assembly has a one-piece bleed pad with P3 boss.
