**FEDERAL AVIATION ADMINISTRATION  
AIRWORTHINESS DIRECTIVES**

**SMALL AIRPLANES, ROTORCRAFT, GLIDERS,  
BALLOONS, & AIRSHIPS**

**BIWEEKLY 2017-16**

*7/24/2017 - 8/6/2017*

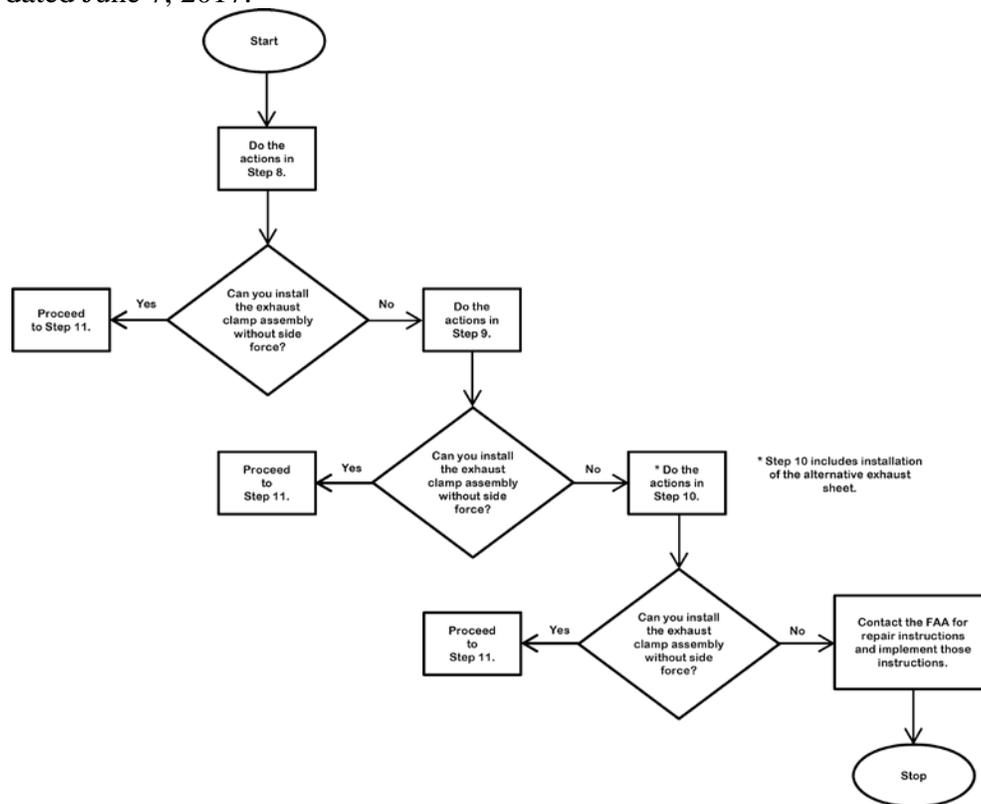
Figure 1 to paragraph (f)(1)(ii) of this AD:  
Sequence of Actions for Exhaust Clamp Installation of  
DAI Work Instruction WI-MSB 42-120, Revision 3, dated July 6, 2017

This AD was prompted by cracks in the affected engine exhaust pipes, which could cause failure of the propeller regulating valve because of hot exhaust gases coming from the fractured pipes. We are issuing this AD to prevent an uncommanded engine in-flight shutdown or overheat damage, which could result in a forced landing, consequent damage, and occupant injury.

(ii) Reinstall any uncracked clamp or replace with a new clamp and incorporate spring washers following III.2 Action 2—installation of additional exhaust clamp in the INSTRUCTIONS section of DAI Work Instruction WI-MSB 42-120, Revision 3, dated July 6, 2017, as specified in DAI Mandatory Service Bulletin

MSB 42-120/2, dated June 7, 2017. See figure 1 to paragraph (f)(1)(ii) of this AD for additional information on the sequence of installation actions as identified in DAI Work Instruction WI-MSB 42-120, Revision 3, dated July 6, 2017. Credit is not given for installation of an engine exhaust clamp installed following DAI Work Instruction WI-MSB 42-120, Revision 1, dated December 14, 2016, (installation of exhaust clamp without spring washers), or DAI Work Instruction MSB-42-120, Revision 2, dated June 7, 2017.
