**FEDERAL AVIATION ADMINISTRATION
AIRWORTHINESS DIRECTIVES**

**SMALL AIRPLANES, ROTORCRAFT, GLIDERS,
BALLOONS, & AIRSHIPS**

BIWEEKLY 2018-20

2018-17-15 Honeywell International Inc. (Type Certificate previously held by AlliedSignal Inc., Garrett Engine Division; Garrett Turbine Engine Company; and AiResearch Manufacturing Company of Arizona): Amendment 39-19369; Docket No. FAA-2018-0479; Product Identifier 2016-NE-23-AD.

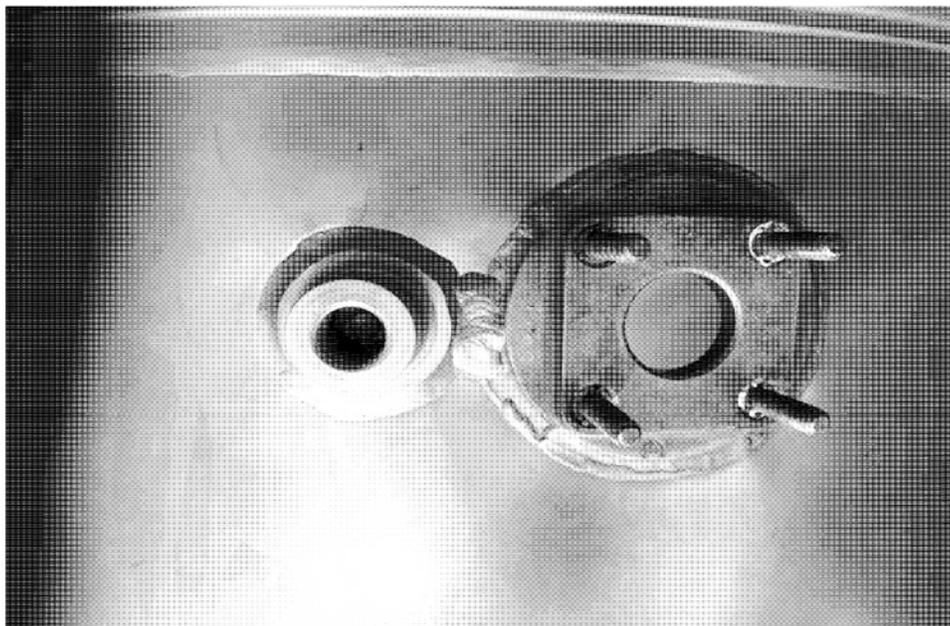
Figure 1 to Paragraph (h) of this AD. Combustion Chamber Case Assembly Without the One-Piece Bleed Pad with P3 Boss

This AD was prompted by reports that combustion chamber case assemblies have cracked and ruptured. We are issuing this AD to prevent failure of the combustion chamber case assembly. The unsafe condition, if not addressed, could result in failure of the combustion chamber case assembly, in-flight shutdown, and reduced control of the airplane.

(2) Figures 1 and 2 to paragraph (h) of this AD illustrate the appearance of combustion chamber case assembly, P/N 893973-5, without and with, respectively, the one-piece bleed pad with the P3 boss.

(2) For TPE331-3U, -3UW, -5, -5A, -5AB, -5B, -6, and -6A engine models with combustion chamber case assemblies, P/Ns 869728-1, 869728-3, or 893973-5, installed, and without the one-piece bleed pad with P3 boss; and for TPE331-1, -2, and -2UA engine models modified by National Flight Services, Inc., supplemental type certificate (STC) SE383CH, remove the combustion chamber case assembly from service at the next removal of the combustion chamber case assembly from the engine, not to exceed 3,700 hours TIS since last hot section inspection.

After the effective date of this AD, do not install a combustion chamber case assembly, P/N 869728-1, 869728-3, or 893973-5, in TPE331-3U, -3UW, -5, -5A, -5AB, -5B, -6, and -6A engine models or in TPE331-1, -2, and -2UA engine models modified by National Flight Services, Inc., STC SE383CH, unless the combustion chamber case assembly has a one-piece bleed pad with P3 boss.
