**FEDERAL AVIATION ADMINISTRATION
AIRWORTHINESS DIRECTIVES**

**SMALL AIRPLANES, ROTORCRAFT, GLIDERS,
BALLOONS, & AIRSHIPS**

BIWEEKLY 2014-06

2011-22-05 R1 Airbus Helicopters (Type Certificate Previously Held by Eurocopter France) (Airbus Helicopters): Amendment 39-17765; Docket No. FAA-2011-1158; Directorate Identifier 2010-SW-018-AD.

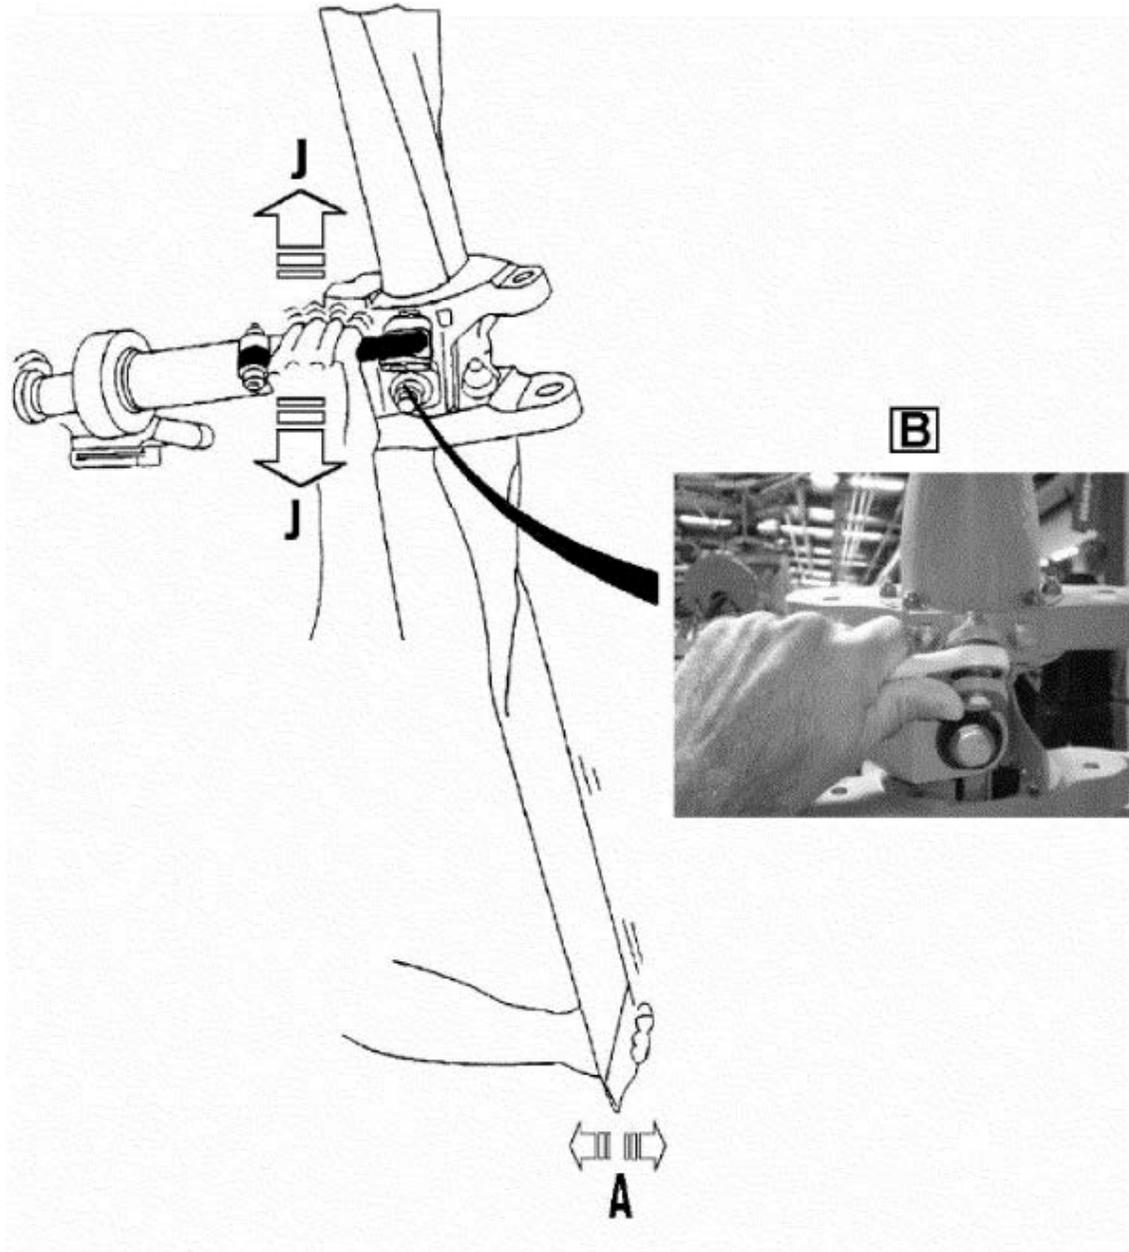
Figure 1 to Paragraph (f)
Manual Check for Play of the Tail Rotor Pitch Control Rod

This AD defines the unsafe condition as excessive play in the control rod. This condition could result in failure of a T/R control rod, loss of T/R control, and subsequent loss of control of the helicopter.

(1) Within 30 hours time-in-service (TIS) and, if no bearing play is detected, thereafter at intervals not to exceed 30 hours TIS, place the T/R pedals in the neutral position. If the helicopter is fitted with a T/R load compensator, discharge the accumulator as described in the rotorcraft flight manual. Check the control rod bearing (bearing) for play on the helicopter, by observation and feel, by slightly moving the T/R blade in the flapping axis while monitoring the bearing for movement. See the following Figure 1 to Paragraph (f) of this AD. The actions required by this paragraph may be performed by the owner/operator (pilot) holding at least a private pilot certificate, and must be entered into the helicopter maintenance records showing compliance with this AD in accordance with 14 CFR 43.9(a)(1)-(4) and 14 CFR 91.417(a)(2)(v). The record must be maintained as required by 14 CFR 91.417, 121.380, or 135.439.

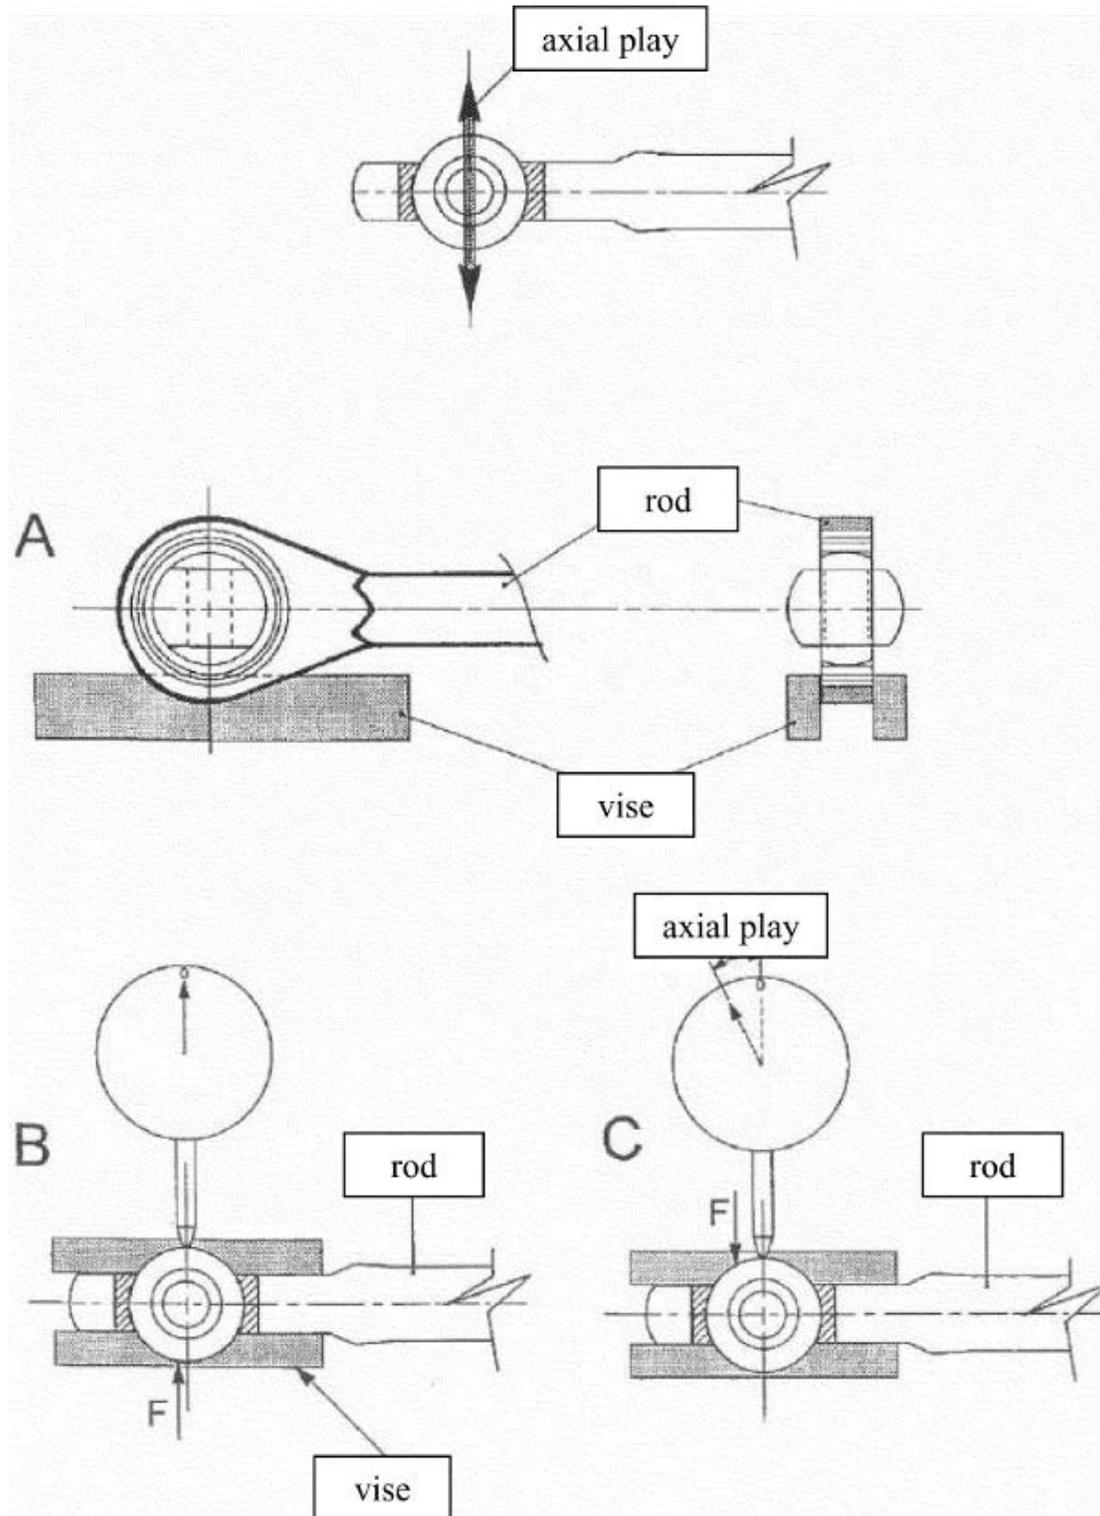
Figure 2 to Paragraph (f)
Measurement of the Axial Play (A) of the Bearing

(2) If a pilot or mechanic detects play in the bearing, before the next flight, a mechanic must remove the control rod from the helicopter, and using a dial indicator, measure the bearing wear according to the following and as shown in Figures 2 and 3 to Paragraph (f) of this AD:

- (i) Remove the control rod from the helicopter.
- (ii) Mount the control rod in a vise as shown in Figure 2 to Paragraph (f) of this AD.
- (iii) Using a dial indicator, take axial play readings by moving the spherical bearing in the direction F (up and down) as shown in Figure 2 to Paragraph (f) of this AD.

- (vii) Record the hours of operation on each control rod.
- (viii) If the radial play exceeds 0.008 inch or axial play exceeds 0.016 inch, replace the control rod with an airworthy control rod before further flight.
