**SAIB:** CE-18-26R1

**Date:** October 30, 2018

**SUBJ:** Liquid Penetrant Inspection; Using Visible Dye Penetrant

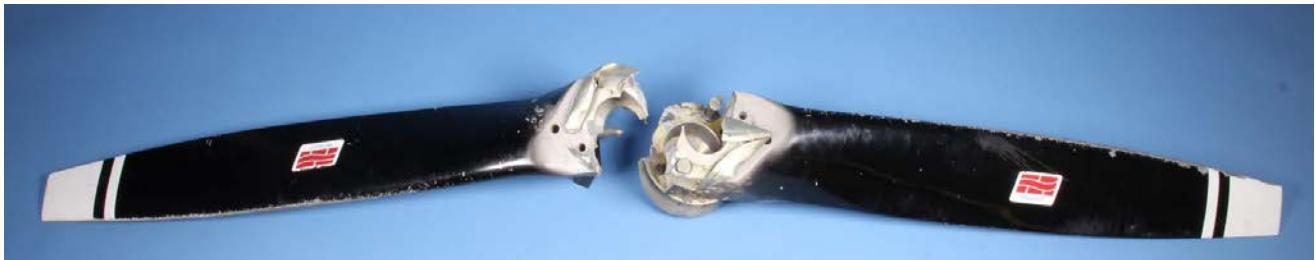
The picture below captures a propeller from an accident. As can be seen, the accident propeller was a single-piece, aluminum, fixed-pitched model. Although the airplane was destroyed, the two occupants survived with serious injuries.

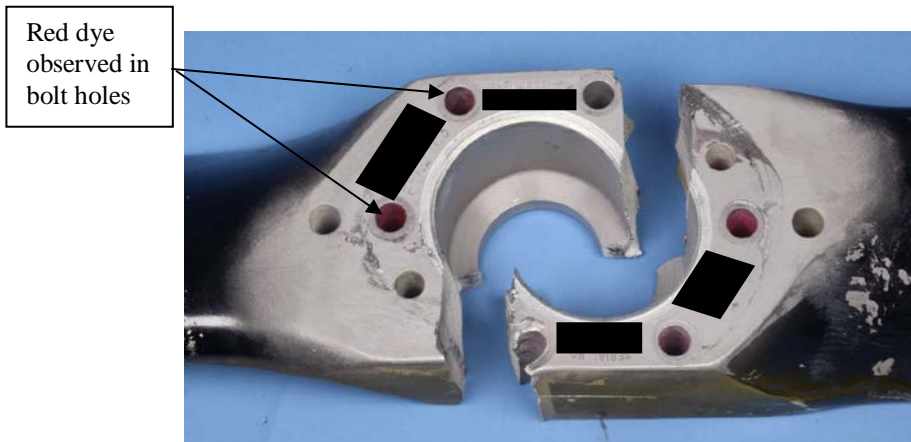
In the photograph above, you can observe residual visible red dye penetrant in some of the propeller hub holes from a prior inspection. It was concluded that post inspection cleaning after the use of red dye was not adequate and did not remove all of the red dye material. Fluorescent dye penetrant was used for the last AD inspection just prior to the propeller failure. Fluorescent penetrant inspection loses effectiveness when there is improper cleaning of red dye from a previous inspection. Visible dye material residue can be extremely difficult to remove and can fill voids, flaws, and cracks, which can affect subsequent inspections. Visible dye residue contamination of fluorescent penetrant fluid is also known to significantly reduce the brightness of fluorescent indication and can mask the fluorescent agent, causing flaws in the part to be minimized or missed at the next inspection.

Due to these characteristics, visible dye penetrants can make existing cracks nearly impossible to detect when using fluorescent penetrant inspection for the next inspection. Pre- and post-inspection cleaning is critical to ensure the ability to detect cracks during current and follow-on inspections and is essential to ensure proper detection of the anomalies and cracks in the article. Inspection material residuals can also lead to corrosion.

- Be aware of the risks associated with using visible dye penetrant inspection methods.
- Per FAA policy, do not use visible dye penetrant using ordinary white light for the inspection of safety critical engine, propeller, or APU hardware. (Ref. Policy Memo PS-ANE100-2000-00010).

- Adhere to the prohibition contained in American Society for Testing and Materials (ASTM E 1417), which prohibits the use of Type II visible dye penetrant prior to the use of Type I fluorescent penetrants for the same surface.

- Adhere to the DAH pre- and post-inspection cleaning methods and materials to ensure any residual developer, penetrant, and/or visible dye residues are removed which could affect subsequent inspections.
