**FEDERAL AVIATION ADMINISTRATION
AIRWORTHINESS DIRECTIVES**

**SMALL AIRPLANES, ROTORCRAFT, GLIDERS,
BALLOONS, & AIRSHIPS**

BIWEEKLY 2020-25

2020-23-03 Airbus Helicopters: Amendment 39-21319; Docket No. FAA-2018-0893; Product Identifier 2018-SW-032-AD.

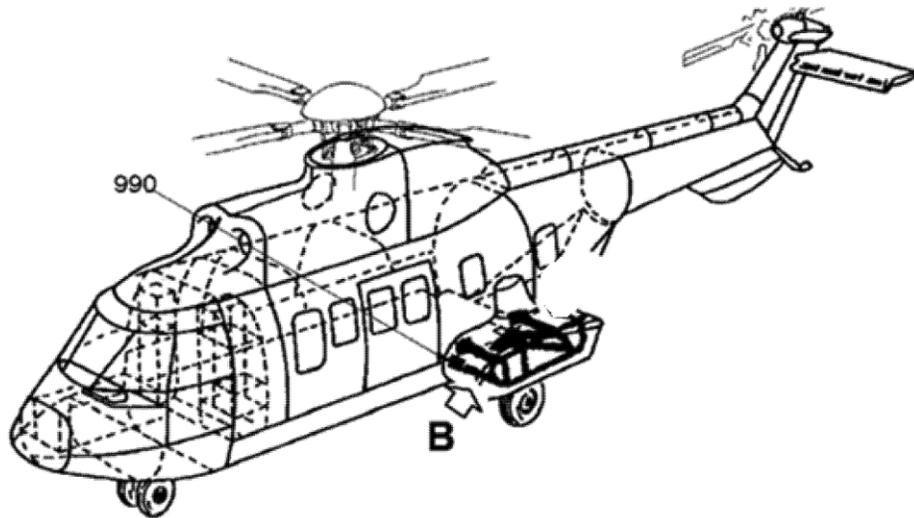
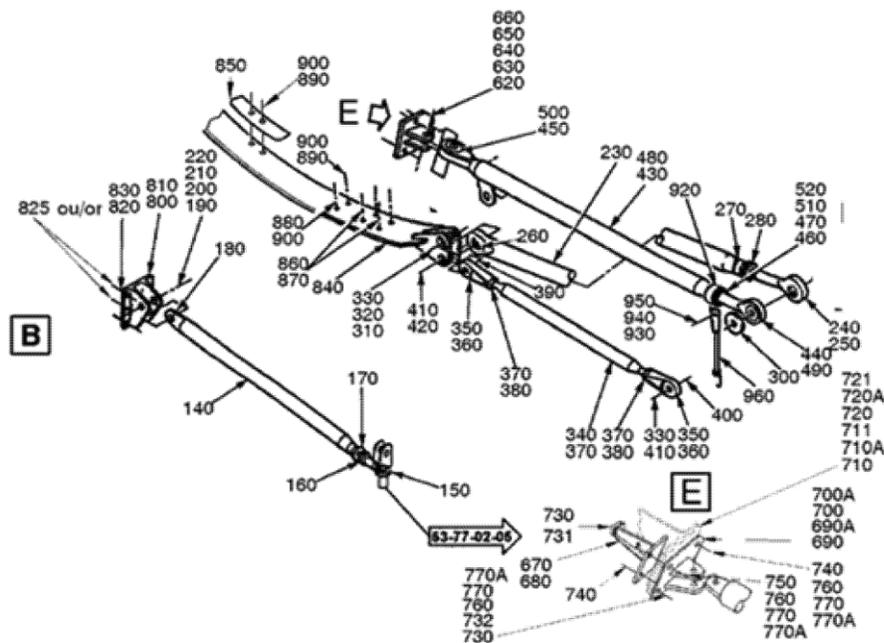
Figure 1 to Paragraph (f)(1)

This AD defines the unsafe condition as failure of a rear upper screw fitting on the emergency flotation gear. This condition, if not detected and corrected, could result in failure of the emergency flotation system and subsequent capsizing of the helicopter.

(1) Within 15 hours time-in-service (TIS), and before each flight over water thereafter, visually check each emergency flotation gear left hand (LH) and right hand (RH) rear upper fitting to determine whether the heads of the lower screws are present. Figure 1 to paragraph (f)(1) of this AD depicts where the lower three screws (noted as B and E) are located. Check each screw for looseness by determining whether it can be rotated by hand. These actions may be performed by the owner/operator (pilot) holding at least a private pilot certificate and must be entered into the aircraft records showing compliance with this AD in accordance with 14 CFR 43.9(a)(1) through (4) and 14 CFR 91.417(a)(2)(v). The record must be maintained as required by 14 CFR 91.417, 121.380, or 135.439.

(2) If a screw head is missing, or if a screw is loose, before further flight over water, install MOD 0728456 by completing paragraph (f)(3) of this AD.

(3) Within 300 hours TIS, unless required before further flight over water by paragraph (f)(2) of this AD, install MOD 0728456 by doing the following:
