**FEDERAL AVIATION ADMINISTRATION
AIRWORTHINESS DIRECTIVES**

**SMALL AIRPLANES, ROTORCRAFT, GLIDERS,
BALLOONS, & AIRSHIPS**

BIWEEKLY 2018-08

2018-07-03 Piper Aircraft, Inc: Amendment 39-19234; Docket No. FAA-2018-0245; Product Identifier 2018-CE-012-AD.

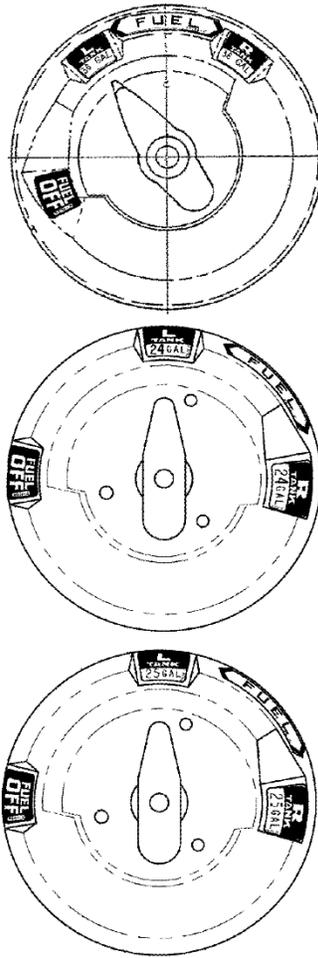
**Figure 2 to the Appendix of AD 2018-07-03, View A-A
Fuel Selector Cover Configurations – Location and Identification**

Note: The pictures are exemplar only to indicate the position of the FUEL OFF, L TANK and R TANK orientation of the placards. The most important aspect of this comparison is the orientation of the FUEL OFF, L TANK, and R TANK placards.

Note: The fuel tank capacity stated on the L TANK and R TANK placards will vary by aircraft model, but the location of these placards with respect to the fuel selector cover must all conform to View A-A

Note: The fuel selector cover placard positions will vary. See Figure 2, View A-A.

(2) Compare the currently installed fuel selector cover to the illustration in Figure 2, View A-A. Examine all placards for proper placement, with specific emphasis on the location of the placards labeled L TANK and R TANK.

(a) If the placards are in the proper locations, then no further action is required. Compliance with this part AD 2018-07-03 must be documented by the owner/operator (pilot) holding at least a private pilot certificate, and must be entered into the aircraft records showing compliance with this AD in accordance with 14 CFR 43.9 (a)(1)-(4) and 14 CFR 91.417(a)(2)(v). The record must be maintained as required by 14 CFR 91.417, 121.380, or 135.439.

(b) If replacement is required, proceed to either paragraph (h) and (i) of AD 2018-07-03.
