**FEDERAL AVIATION ADMINISTRATION  
AIRWORTHINESS DIRECTIVES**

**SMALL AIRPLANES, ROTORCRAFT, GLIDERS,  
BALLOONS, & AIRSHIPS**

**BIWEEKLY 2017-15**

**2017-14-04 Piper Aircraft, Inc.:** Amendment 39-18948; Docket No. FAA-2016-9254; Directorate Identifier 2015-CE-030-AD.

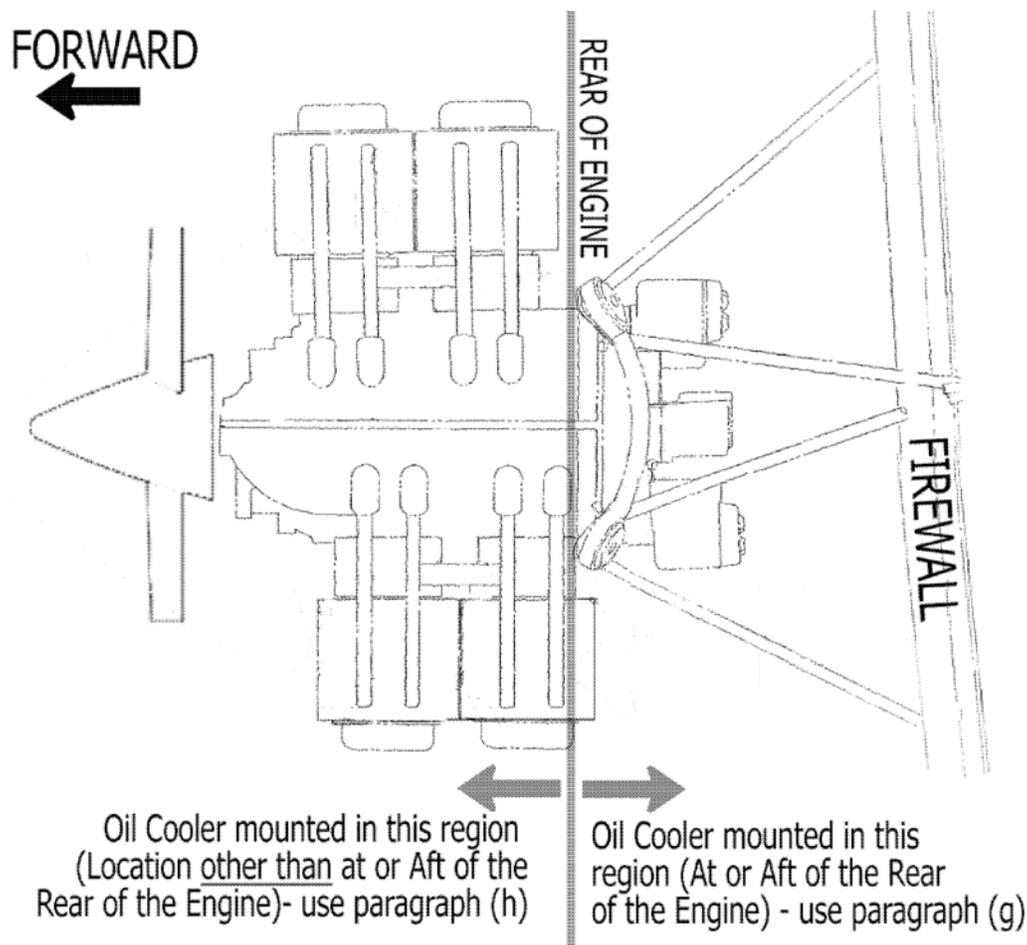
Figure 1 to paragraphs (g) and (h) of this AD: Oil cooler

each oil cooler hose assembly for soaked oil, a brownish or whitish color, and any evidence of brittleness or deterioration as a result of heat or oil seepage. See figure 1 to paragraphs (g) and (h) of this AD for additional information.

(1) For any oil cooler hose assemblies that do not meet TSO-C53a, Type D requirements: Within the next 100 hours TIS after February 5, 1996 (the effective date retained from AD 95-26-13), and repetitively thereafter at intervals not to exceed 100 hours TIS, inspect the fire sleeve of each oil cooler hose assembly for soaked oil, a brownish or whitish color, and any evidence of brittleness or deterioration as a result of heat or oil seepage. See figure 1 to paragraphs (g) and (h) of this AD for additional information.

(1) If any of the conditions described in paragraph (g) or (h)(1) of this AD are found on an oil cooler hose assembly during the inspection required in paragraph (g) or (h)(1) of this AD, as applicable, before further flight, replace the oil cooler hose assembly with a serviceable new or used TSO-C53a Type D oil cooler hose assembly or TSO-C53a Type C oil cooler hose assembly. If a used TSO-C53a Type C oil cooler hose assembly is installed, it must have documented hours TIS.

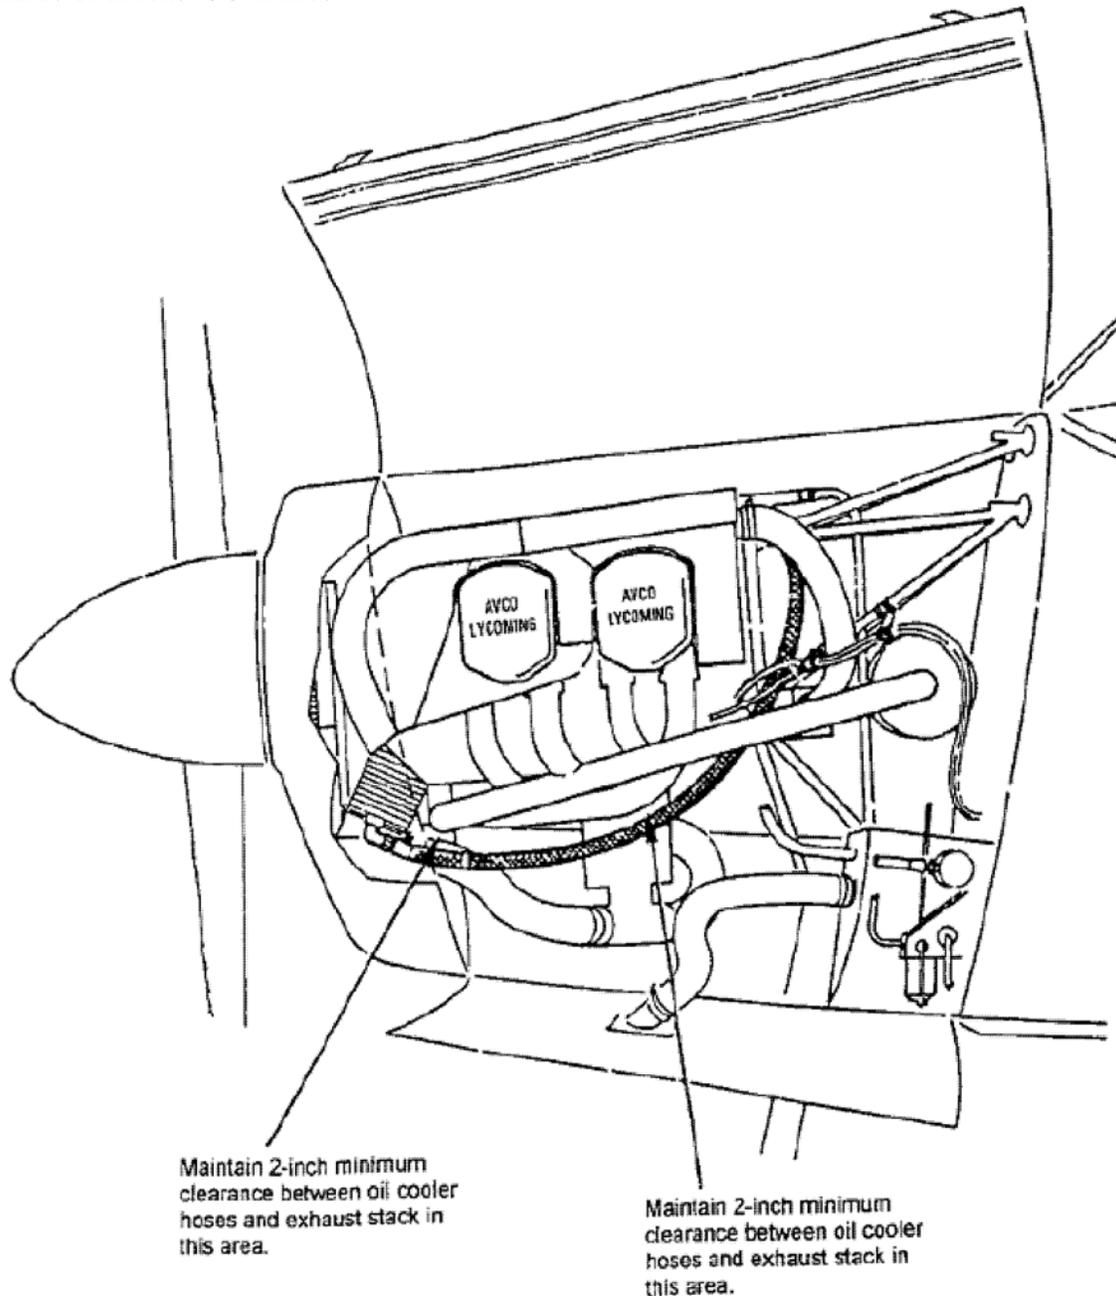
Figure 2 to paragraph (h)(2) of this AD: Acceptable clearances

to ensure the installation conditions in paragraphs (h)(2)(i) through (iii) of this AD are met. See figure 1 to paragraphs (g) and (h) of this AD for additional information. If the conditions listed in paragraphs (h)(2)(i) through (iii) of this AD are not met, before further flight, make any necessary adjustments. See figure 2 to paragraph (h)(2) of this AD for additional information.

(i) The oil cooler hose assemblies pass underneath and behind the electrical ground cable and in front of the lower of the two engine mounts.

(ii) The oil cooler hose assemblies are secured to the engine mount strut and a clearance of at least 2 inches exists between the oil cooler hose assemblies and the exhaust stack.

(iii) Oil cooler hose assemblies with a minimum outer diameter of 0.75 inch are installed with a bend radius of at least 6.5 inches.

(2) If a newly installed oil cooler hose assembly is a TSO-C53a Type C oil cooler hose assembly and it is mounted in a location other than at or aft of the rear of the engine, then replacement of the oil cooler hose assembly must meet the conditions listed in paragraphs (h)(2)(i) through (iii) of this AD.
