**FEDERAL AVIATION ADMINISTRATION
AIRWORTHINESS DIRECTIVES**

**SMALL AIRPLANES, ROTORCRAFT, GLIDERS,
BALLOONS, & AIRSHIPS**

BIWEEKLY 2014-13

6/16/2014 - 6/29/2014

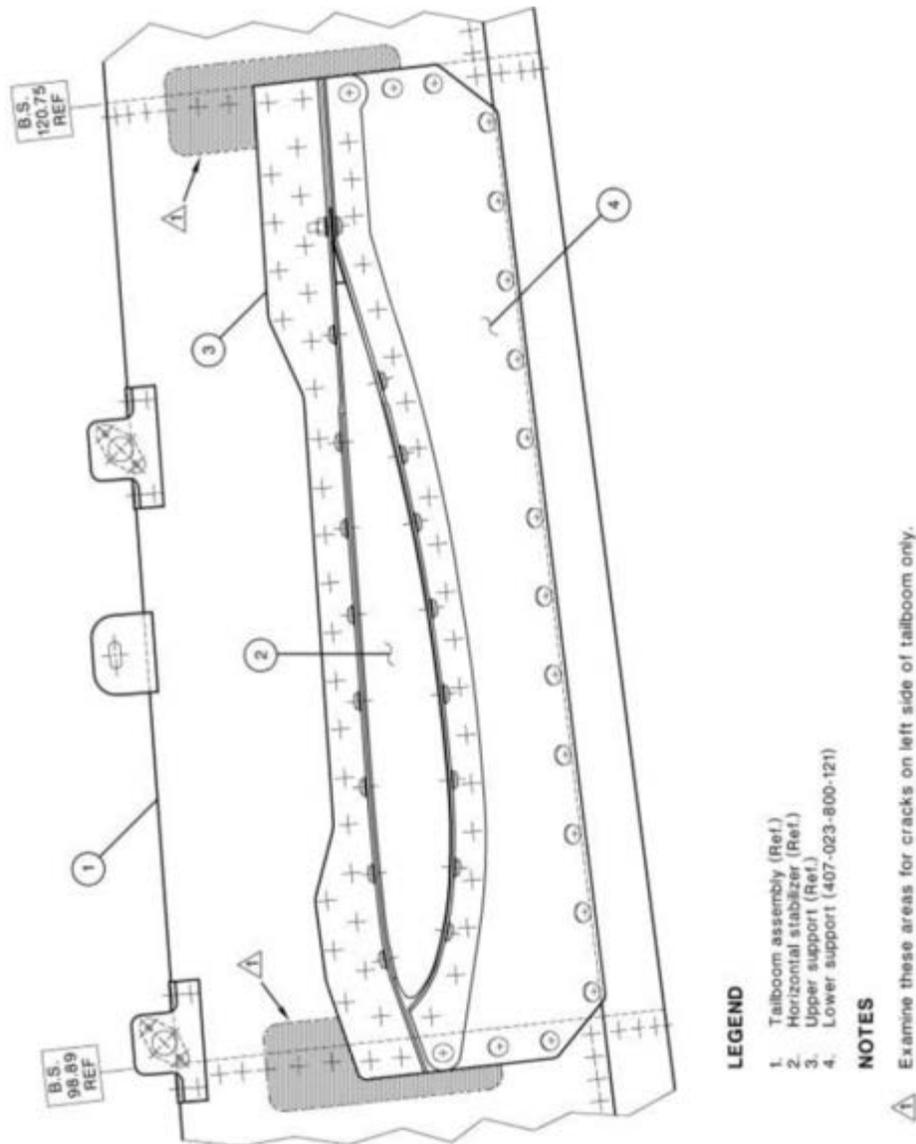
This AD defines the unsafe condition as cracks in the tailboom skin on the left side in the area of horizontal stabilizer, which could result in separation of the tailboom and subsequent loss of control of the helicopter.

(A) Before the first flight of each day, visually check the tailboom for a crack, as depicted in Figure 1 to Paragraph (f)(1)(i)(A) of this AD.

(3) If there is a crack, before further flight, replace the tailboom.

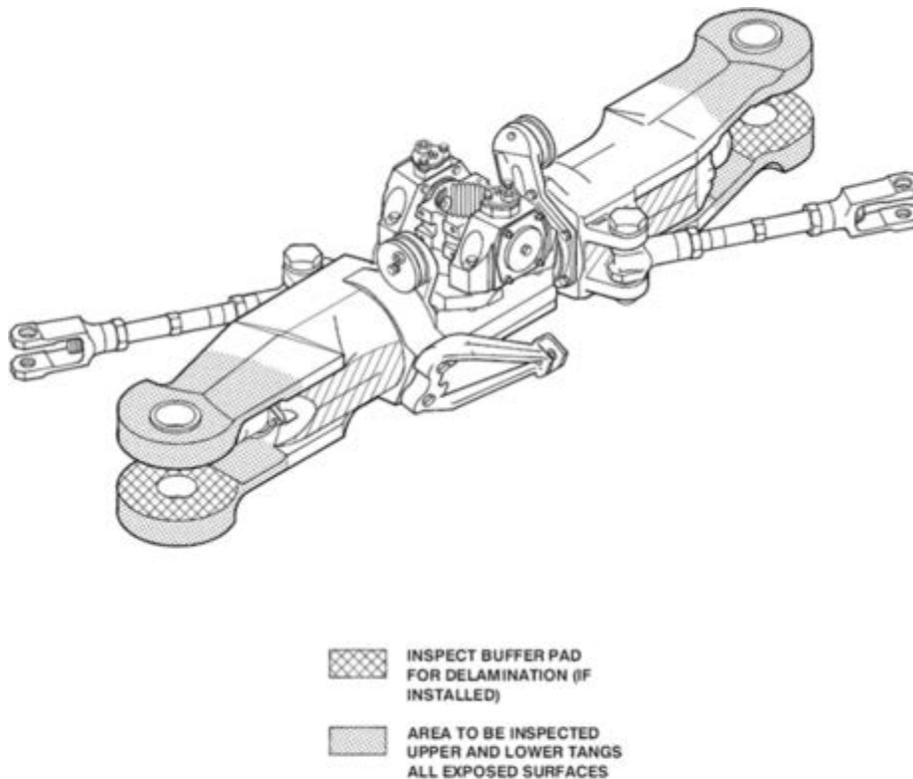
Figure 1 to Paragraphs (f)(2)(ii) and (f)(4)(ii)
Inspection of Main Rotor Hub Grip Tangs

This AD defines the unsafe condition as a crack in the main rotor grip (grip), which could result in failure of a grip, separation of a main rotor blade, and subsequent loss of control of the helicopter.

(ii) Using a 10-power or higher magnifying glass, visually inspect the exposed surfaces of the upper and lower tangs of each grip for a crack. Pay particular attention to the lower surface of each lower grip tang from the main rotor blade bolt-bushing flange to the leading and trailing edge of each grip tang as depicted in Figure 1 to Paragraphs (f)(2)(ii) and (f)(4)(ii) of this AD.

- (i) Remove each main rotor blade, and
- (ii) Inspect each grip buffer pad on the inner surfaces of each grip tang for delamination as depicted in Figure 1 to Paragraphs (f)(2)(ii) and (f)(4)(ii) of this AD. If there is any delamination, remove the buffer pad and inspect the grip surface for corrosion or other damage.

- (i) Replace any cracked grip with an airworthy grip.
- (ii) Replace any grip with any corrosion or other damage with an airworthy grip, or repair the grip if the corrosion or other damage is within maximum repair damage limitations.
- (iii) Replace any grip, P/N 204-011-121-009 or ASI-4011-121-9, which has been in service for 15,000 or more hours TIS.
