**FEDERAL AVIATION ADMINISTRATION
AIRWORTHINESS DIRECTIVES**

**LARGE AIRCRAFT
BIWEEKLY 2019-15**

7/8/2019 - 7/21/2019

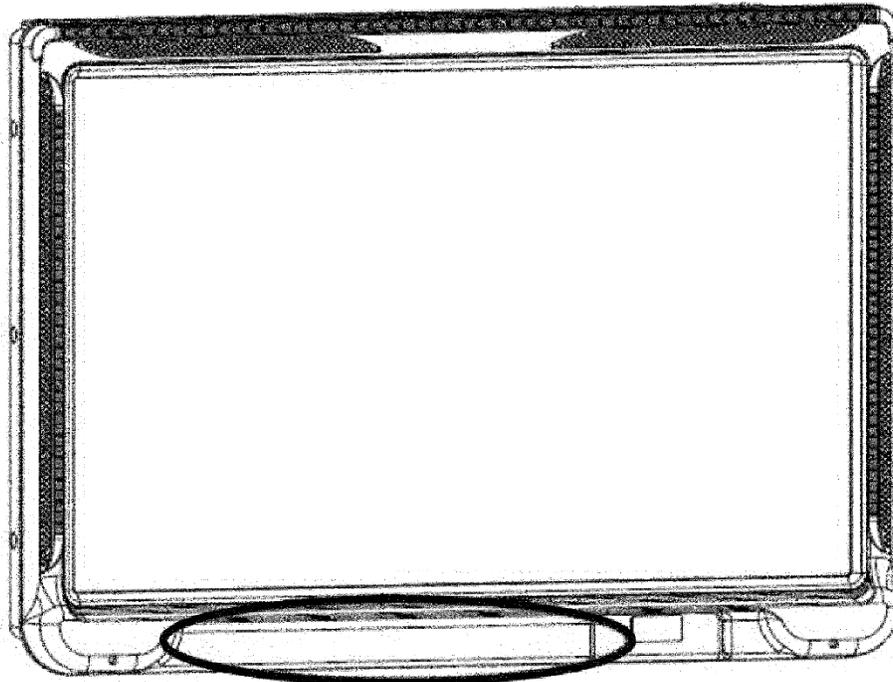
Figure 1 to paragraph (g)(3) of this AD; placard location on bezel

This AD was prompted by a conflict between the traffic collision avoidance system (TCAS) primary display indications and aural alerts during a resolution advisory (RA) scenario. The FAA is issuing this AD to prevent conflicting TCAS information. The unsafe condition, if not addressed, could result in the pilot under-correcting or over-correcting and may lead to inadequate aircraft separation and a mid-air collision.

(2) Fabricate a placard for each aircraft primary flight display, using at least 1/8 inch letters, with the following text: TCAS Flight Ops–TA Only mode (TA/RA mode prohibited).

(3) Install the placard on the bottom of each aircraft primary flight display bezel in the area depicted in figure 1 to paragraph (g)(3) of this AD.
