**FEDERAL AVIATION ADMINISTRATION  
AIRWORTHINESS DIRECTIVES**

**SMALL AIRPLANES, ROTORCRAFT, GLIDERS,  
BALLOONS, & AIRSHIPS**

**BIWEEKLY 2013-22**

*10/21/2013 - 11/3/2013*

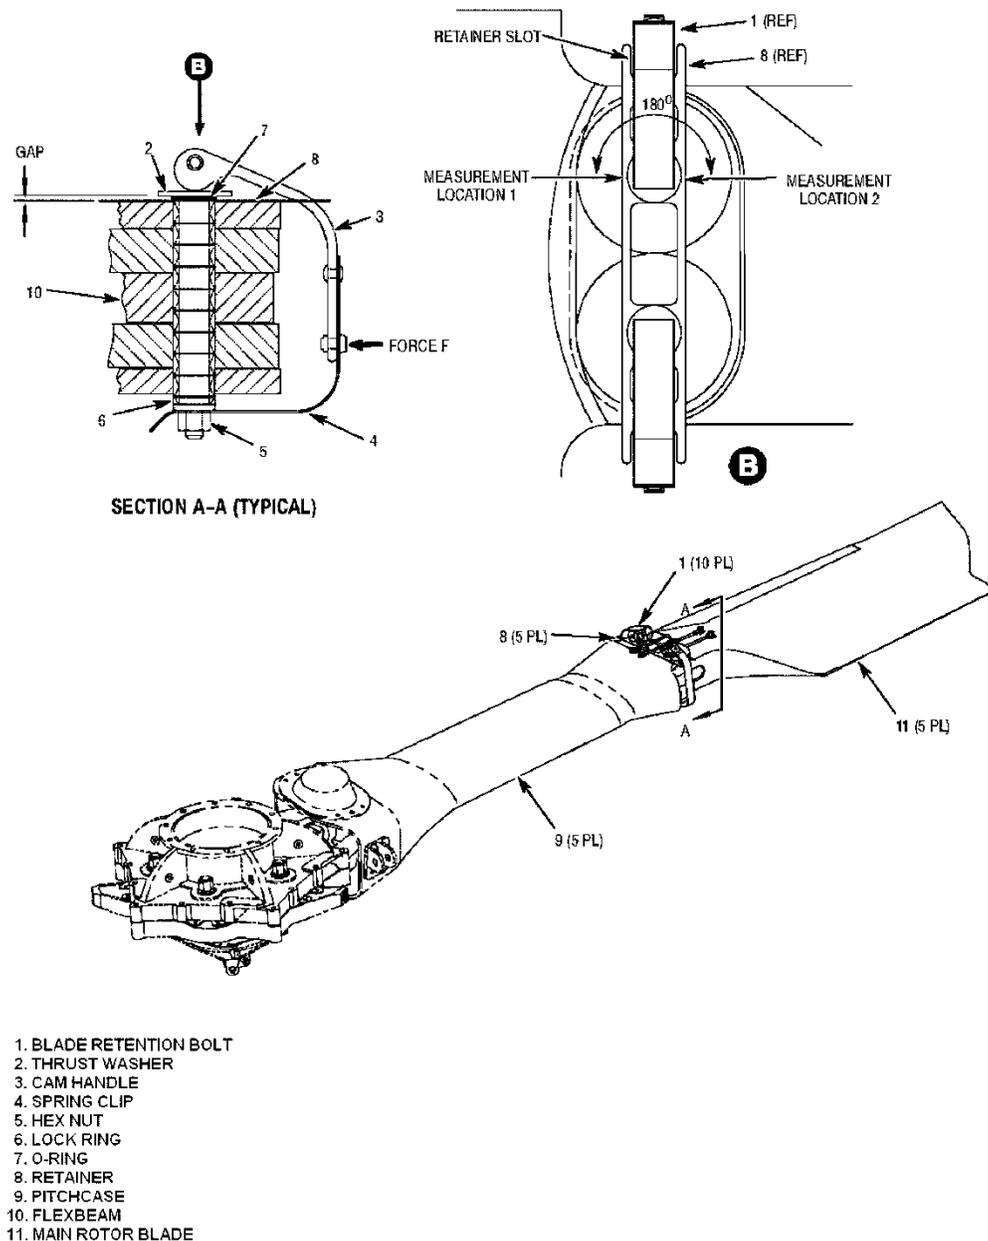
Figure 1 to Paragraph (e)  
Gap and Force Check of the Blade Retention Bolts

(i) Visually check each bolt for failure. Failure of a bolt may be indicated by movement of the bolt out of the bolt hole or by inconsistent extension of the bolt above or below the other bolts being inspected (a failed bolt migrates out of the bolt hole).

(ii) Visually check for a gap between the thrust washer and the retainer, P/N 900R2100009-101 or -103. The thrust washer is depicted as item 2 and the retainer is depicted as item 8 in Figure 1 to paragraph (e) of this AD.

(iv) If there is any indication of bolt failure or if there is no gap between the thrust washer and retainer, before further flight, remove and inspect the bolt for a crack. Replace any cracked bolt with an airworthy bolt.

(ii) If there is no gap between the thrust washer and retainer, before further flight, remove and inspect the bolt for a crack. Replace any cracked bolt with an airworthy bolt.

(iii) If there is a gap between the thrust washer and retainer, measure the gap in two locations, 180 degrees apart, with a feeler gage. If the gap is more than 0.100 inch (2.54 mm) at either location, before further flight, remove and inspect the bolt for a crack. Replace any cracked bolt with an airworthy bolt.
