[Docket No. FAA-2018-0893; Product Identifier 2018-SW-032-AD; Amendment 39-21319; AD 2020-23-03]

Airworthiness Directives; Airbus Helicopters

SUMMARY: The FAA is superseding Airworthiness Directive (AD) 2017-09-05 for Airbus Helicopters Model AS332C, AS332C1, AS332L, AS332L1, AS332L2, and EC225LP helicopters. AD 2017-09-05 required repetitively checking screws in the emergency flotation gear. This new AD retains the requirements of AD 2017-09-05 but also requires installing a modification (MOD), which is a terminating action for the repetitive checks. This AD was prompted by the development of the MOD by Airbus Helicopters that addresses the unsafe condition. The actions of this AD are intended to address an unsafe condition on these products.

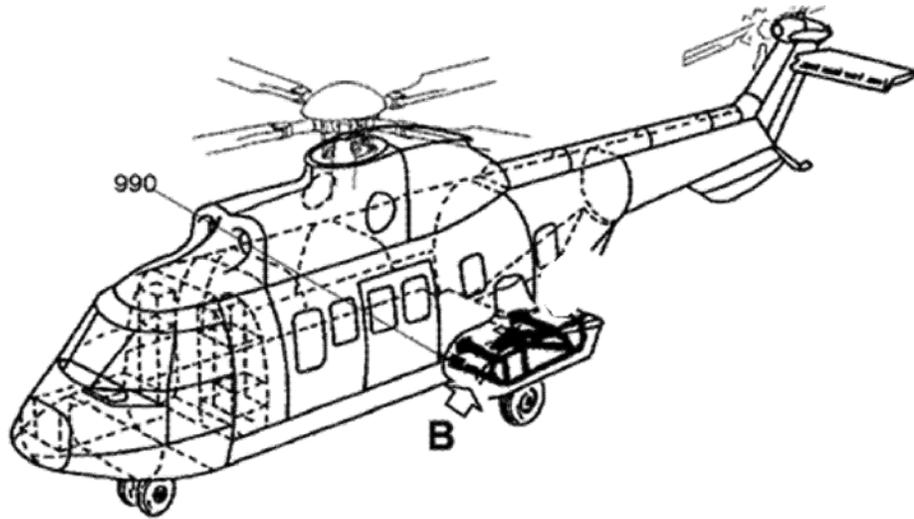
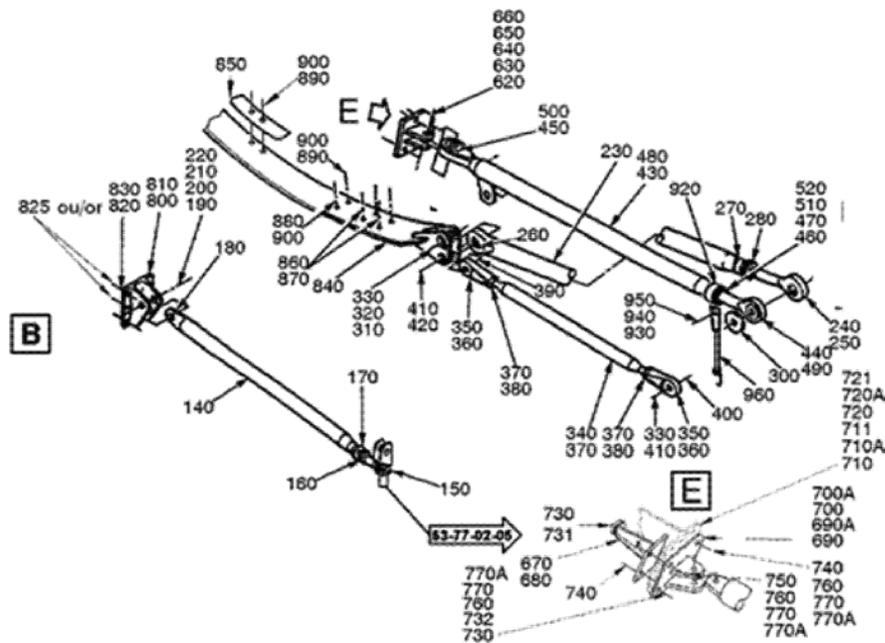
Figure 1 to Paragraph (f)(1)

After the FAA issued AD 2017-09-05, Airbus Helicopters identified the root cause of the screw rupture as a tapering gap under the fitting attachment screw heads creating excessive stress loads. Consequently, EASA issued AD No. 2018-0090, dated April 20, 2018 (EASA AD 2018-0090), to supersede EASA AD 2015-0239-E. EASA AD 2018-0090 retains the repetitive inspection requirements in EASA AD 2015-0239-E and also requires the installation of Airbus Helicopters MOD 0728456 as a terminating action for the repetitive inspections. MOD 0728456 involves the installation of spherical washers and longer screws on the rear upper fittings of the flotation gear to remove the stress applied to the screw heads.

This AD defines the unsafe condition as failure of a rear upper screw fitting on the emergency flotation gear. This condition, if not detected and corrected, could result in failure of the emergency flotation system and subsequent capsizing of the helicopter.

(1) Within 15 hours time-in-service (TIS), and before each flight over water thereafter, visually check each emergency flotation gear left hand (LH) and right hand (RH) rear upper fitting to determine whether the heads of the lower screws are present. Figure 1 to paragraph (f)(1) of this AD depicts where the lower three screws (noted as B and E) are located. Check each screw for looseness by determining whether it can be rotated by hand. These actions may be performed by the owner/operator (pilot) holding at least a private pilot certificate and must be entered into the aircraft records showing compliance with this AD in accordance with 14 CFR 43.9(a)(1) through (4) and 14 CFR 91.417(a)(2)(v). The record must be maintained as required by 14 CFR 91.417, 121.380, or 135.439.

(2) If a screw head is missing, or if a screw is loose, before further flight over water, install MOD 0728456 by completing paragraph (f)(3) of this AD.

(3) Within 300 hours TIS, unless required before further flight over water by paragraph (f)(2) of this AD, install MOD 0728456 by doing the following:
