**FEDERAL AVIATION ADMINISTRATION
AIRWORTHINESS DIRECTIVES**

**SMALL AIRPLANES, ROTORCRAFT, GLIDERS,
BALLOONS, & AIRSHIPS**

BIWEEKLY 2018-07

3/19/2018 - 4/1/2018

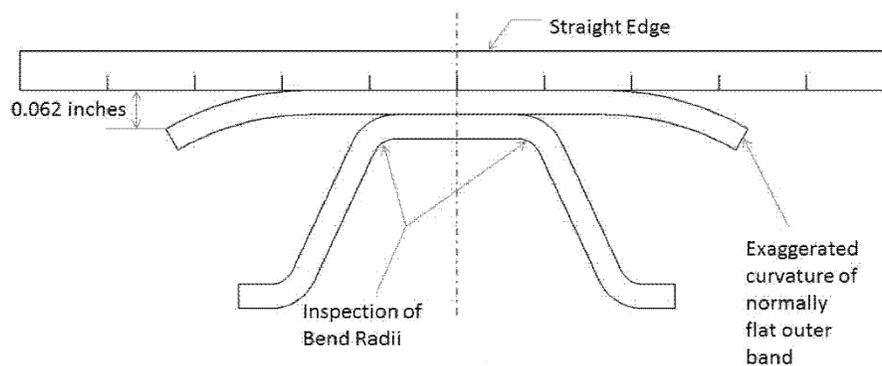
Figure 1 to paragraphs (k)(1)(iii) and (v) of this AD: Cross section of v-band coupling

(iii) Visually inspect the flatness of the outer band using a straight edge. Lay the straight edge across the width of the outer band. The gap must be less than 0.062 inches. See figure 1 to paragraphs (k)(1)(iii) and (v) of this AD. If the gap exceeds 0.062 inches between the outer band and the straight edge, do not re-install the v-band coupling. Before further flight, you must install a new v-band coupling and restart the hours TIS for the repetitive replacement of the v-band coupling.

(v) Visually inspect the bend radii of the coupling v-retainer coupling segments for cracks. Inspect the radii throughout the length of the segment. See figure 1 to paragraphs (k)(1)(iii) and (v) of this AD. If any cracks are found, do not re-install the v-band coupling. Before further flight, you must install a new v-band coupling and restart the hours TIS for the repetitive replacement of the v-band coupling.
