**FEDERAL AVIATION ADMINISTRATION
AIRWORTHINESS DIRECTIVES**

LARGE AIRCRAFT

BIWEEKLY 2016-17

8/8/2016 - 8/21/2016

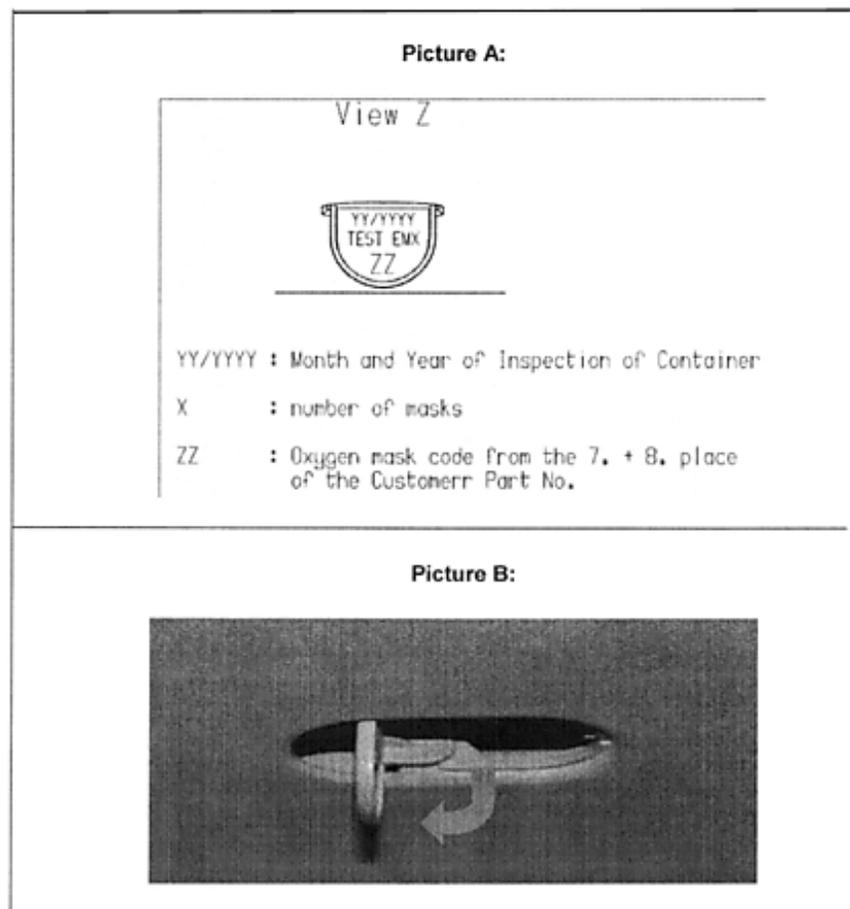
Figure 1 to Paragraph (I)(4) of this AD – Design A of the Passenger Oxygen Containers

Note 2 to paragraph (I)(4) of this AD: For "Design A," the placard on the passenger oxygen container test button is as described in "Picture A" in figure 1 to paragraph (I)(4) of this AD. The mask configuration ("ZZ" in "Picture A") is a number, and the test button is as shown in "Picture B."
