**FEDERAL AVIATION ADMINISTRATION  
AIRWORTHINESS DIRECTIVES**

**LARGE AIRCRAFT  
BIWEEKLY 2016-06**

*3/7/2016 - 3/20/2016*

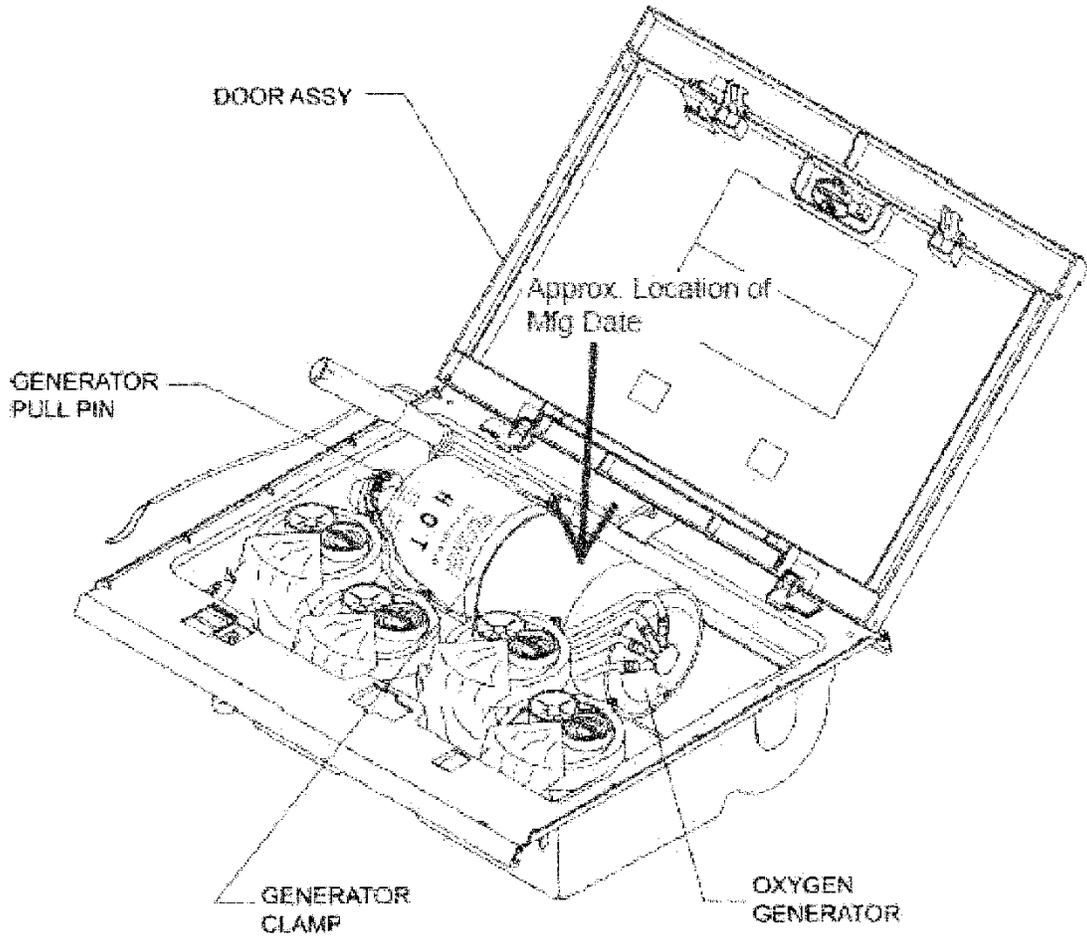
**Figure 1 to paragraph (g) of this AD - Location of date (MM-YY)**

This AD was prompted by reports of premature aging of certain chemical oxygen generators in the passenger compartment that resulted in failure of the generators to activate. We are issuing this AD to prevent failure of the chemical oxygen generator to activate during an emergency situation, which could result in unavailability of oxygen and possible incapacitation of the occupants.

If, during any inspection required by paragraph (g) of this AD, any passenger chemical oxygen generator having a date of manufacture of 1999, 2000, or 2001 is found: At the time specified in paragraph (h)(1), (h)(2), or (h)(3) of this AD, as applicable, replace the affected passenger chemical oxygen generator, in accordance with the Instructions of Airbus AOT A35L007-14, Revision 01, June 17, 2015; including Appendix A, Revision 01, dated June 17, 2015 (for 15- and 22-minute passenger chemical oxygen generators); or in accordance with the Accomplishment Instructions of B/E Aerospace Service Bulletin 117042-35-001, dated December 10, 2014 (for 15-minute passenger chemical oxygen generators).

If, during any inspection required by paragraph (g) of this AD, any passenger chemical oxygen generator having a date of manufacture of 2002 or later is found: At the time specified in paragraph

(i)(1), (i)(2), (i)(3), (i)(4), (i)(5), (i)(6), (i)(7), or (i)(8) of this AD, as applicable, replace the affected passenger chemical oxygen generator with a serviceable unit, in accordance with the Instructions of Airbus AOT A35L007-14, Revision 01, June 17, 2015; including Appendix A, Revision 01, dated June 17, 2015 (for 15- and 22-minute passenger chemical oxygen generators); or in accordance with the Accomplishment Instructions of B/E Aerospace Service Bulletin 117042-35-001, dated December 10, 2014 (for 15-minute passenger chemical oxygen generators).
