**FEDERAL AVIATION ADMINISTRATION
AIRWORTHINESS DIRECTIVES**

**LARGE AIRCRAFT
BIWEEKLY 2014-16**

7/28/2014 - 8/10/2014

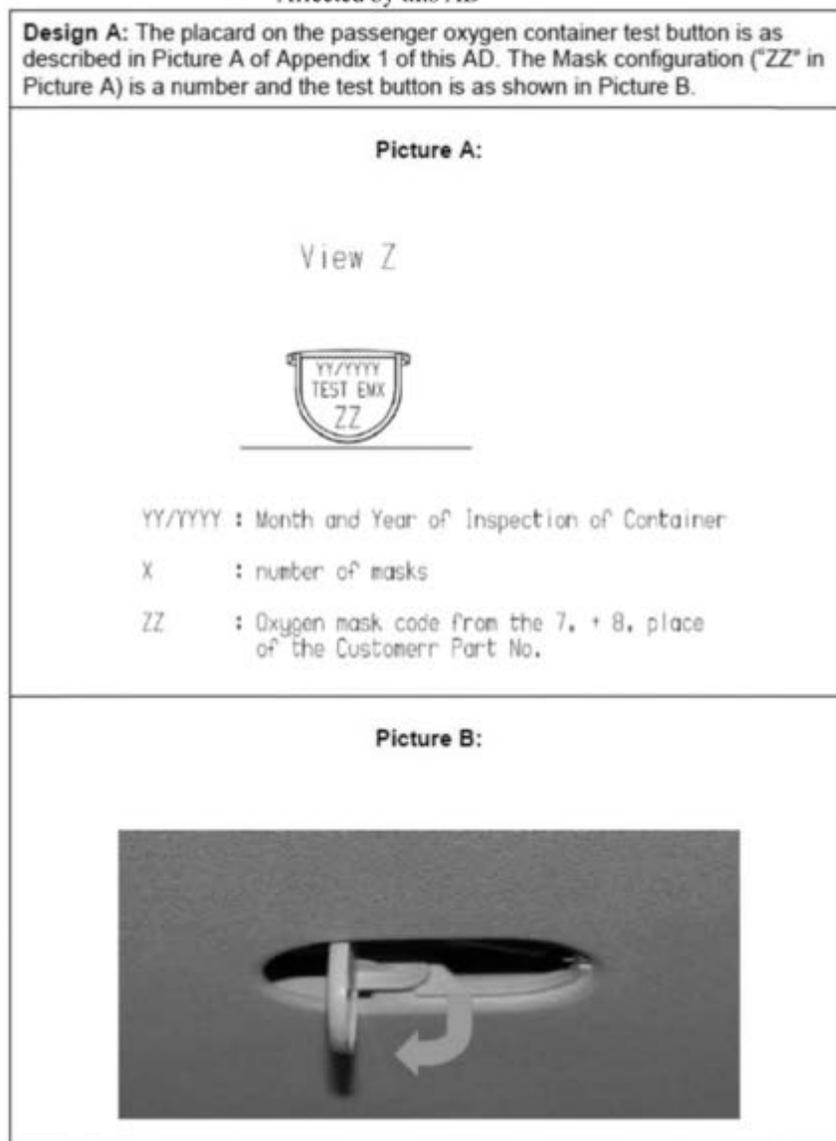
Figure 1 to paragraph (i)(7) of this AD – Design A of the Passenger Oxygen Containers Affected by this AD

(7) The requirements of paragraphs (g) and (h) of this AD apply only to passenger oxygen containers that are Design A, as defined in figure 1 to paragraph (i)(7) of this AD.
