**FEDERAL AVIATION ADMINISTRATION  
AIRWORTHINESS DIRECTIVES**

**SMALL AIRPLANES, ROTORCRAFT, GLIDERS,  
BALLOONS, & AIRSHIPS**

**BIWEEKLY 2013-09**

*4/22/2013 - 5/5/2013*

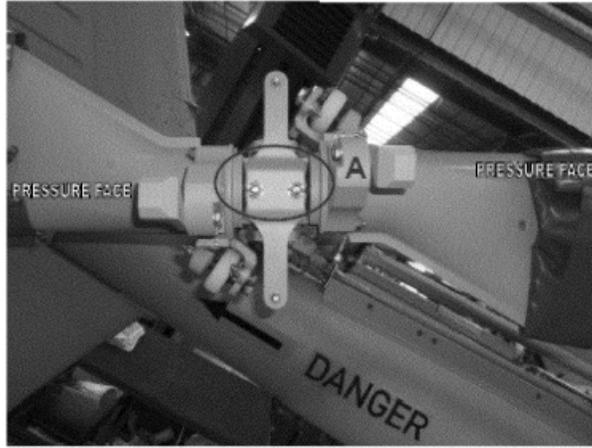
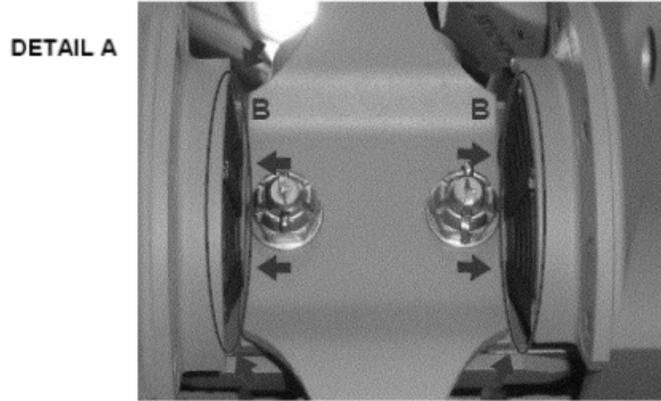
This AD defines the unsafe condition as severe vibrations due to failure of laminated half-bearings (bearings). This condition could result in failure of the tail rotor and subsequent loss of control of the helicopter.

- (i) Position both tail rotor blades horizontally.
- (ii) Apply load (F) by hand, perpendicular to the pressure face of one tail rotor blade (a), as shown in Figure 1 to paragraph (f) of this AD, taking care not to reach the extreme position against the tail rotor hub. The load will deflect the tail rotor blade towards the tail boom.
- (iii) While maintaining the load, check all the visible faces of the bearings (front and side faces) in area B of DETAIL A of Figure 1 to paragraph (f) of this AD for separation between the elastomer and metal parts, a crack in the elastomer, or an extrusion (see example in Figure 2 to paragraph (f) of this AD). A flashlight may be used to enhance the check.

(5) If there is an extrusion on any bearing, before further flight, replace the four bearings with airworthy bearings.

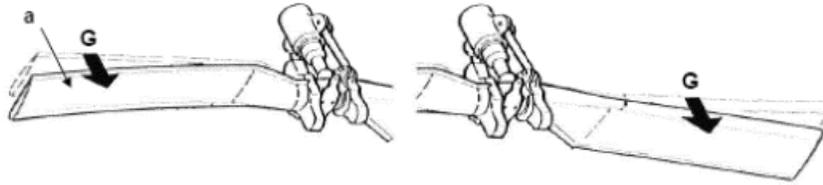
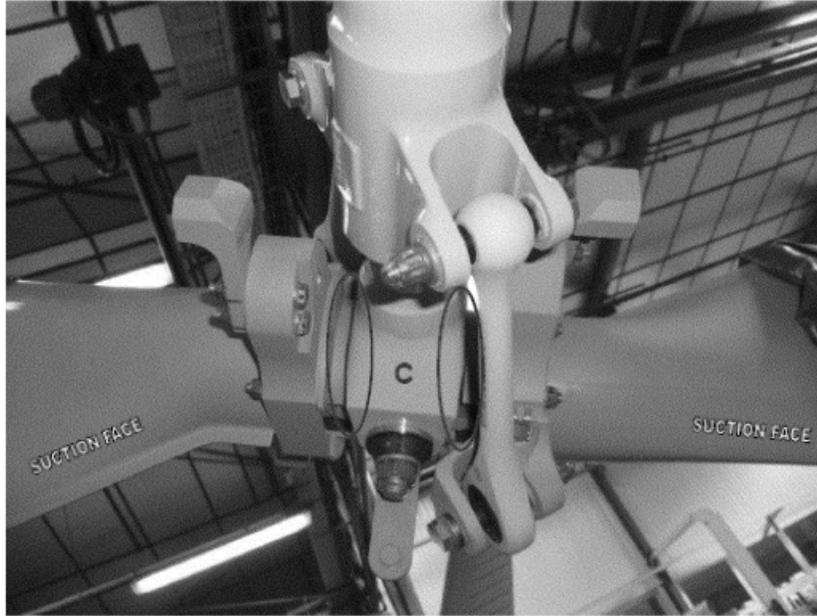
(vi) While maintaining the load, check visible faces of Area C as shown in Figure 3 to paragraph (f) of this AD for any extrusion. A flashlight may be used to enhance the check.

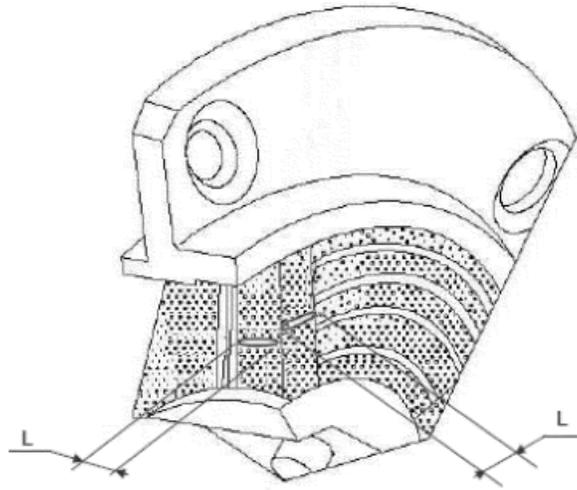
Figure 4 to paragraph (f)

(6) If there is a separation or a crack on the pressure side bearing, measure the separation or the crack. If the separation or crack is greater than 5 millimeters (.196 inches) as indicated by dimension "L" in Figure 4 to paragraph (f), before further flight, replace the four bearings with airworthy bearings.

(7) No later than after the last flight of the day, perform a one-time inspection by removing the bearings and inspecting for a separation, a crack, or an extrusion. This inspection is not a daily inspection. If there is a separation, crack, or extrusion, before further flight, replace the four bearings with airworthy bearings.
