**FEDERAL AVIATION ADMINISTRATION
AIRWORTHINESS DIRECTIVES**

**SMALL AIRPLANES, ROTORCRAFT, GLIDERS,
BALLOONS, & AIRSHIPS**

BIWEEKLY 2015-12

6/1/2015 - 6/14/2015

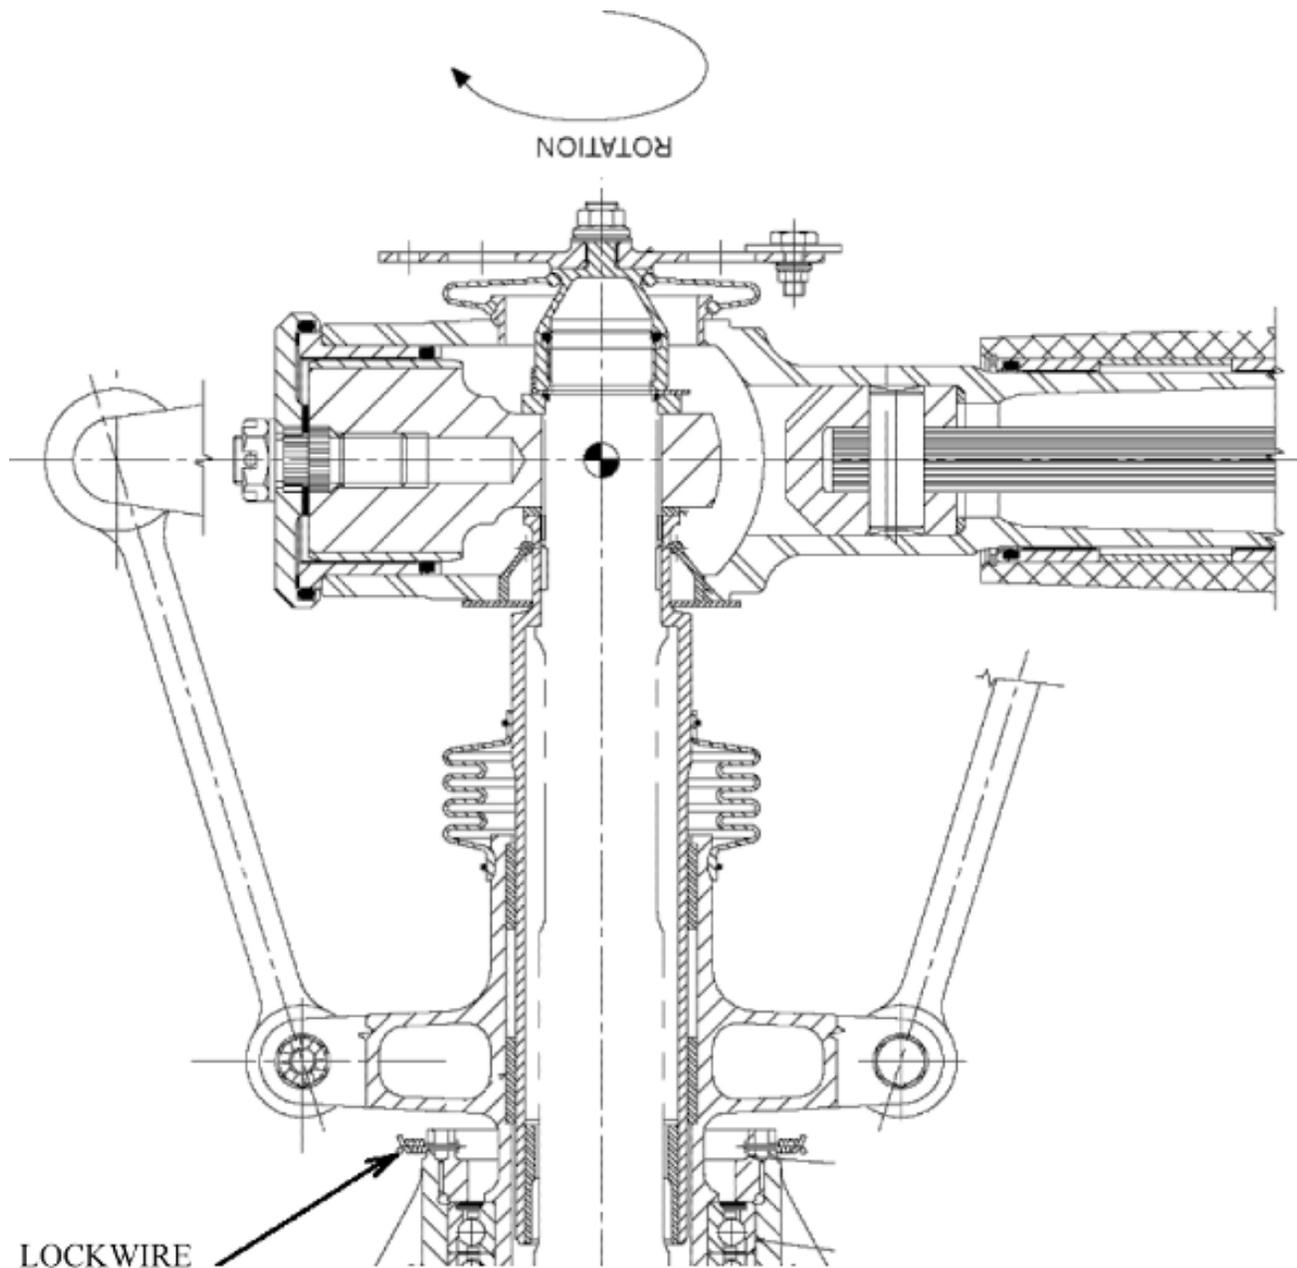
Figure 1 of paragraph (f)(1)

This AD defines the unsafe condition as a missing or broken lock wire securing the tail rotor (T/R) duplex bearing locking nut (locking nut). This condition could result in loosening of the locking nut, failure of the T/R, and subsequent loss of control of the helicopter.

(1) Within 24 hours and thereafter before the first flight of each day or at intervals not exceeding 24 hours, whichever occurs later, check each lock wire securing the T/R locking nut to the housing. The location of the housing wire is depicted in Figure 1 to paragraph (f)(1) of this AD.

(4) If one or both lock wires are missing or damaged, before further flight, remove and reassemble the housing and slider group of the T/R rotating controls.
