**FEDERAL AVIATION ADMINISTRATION
AIRWORTHINESS DIRECTIVES**

**SMALL AIRPLANES, ROTORCRAFT, GLIDERS,
BALLOONS, & AIRSHIPS**

BIWEEKLY 2020-11

5/11/2020 - 5/24/2020

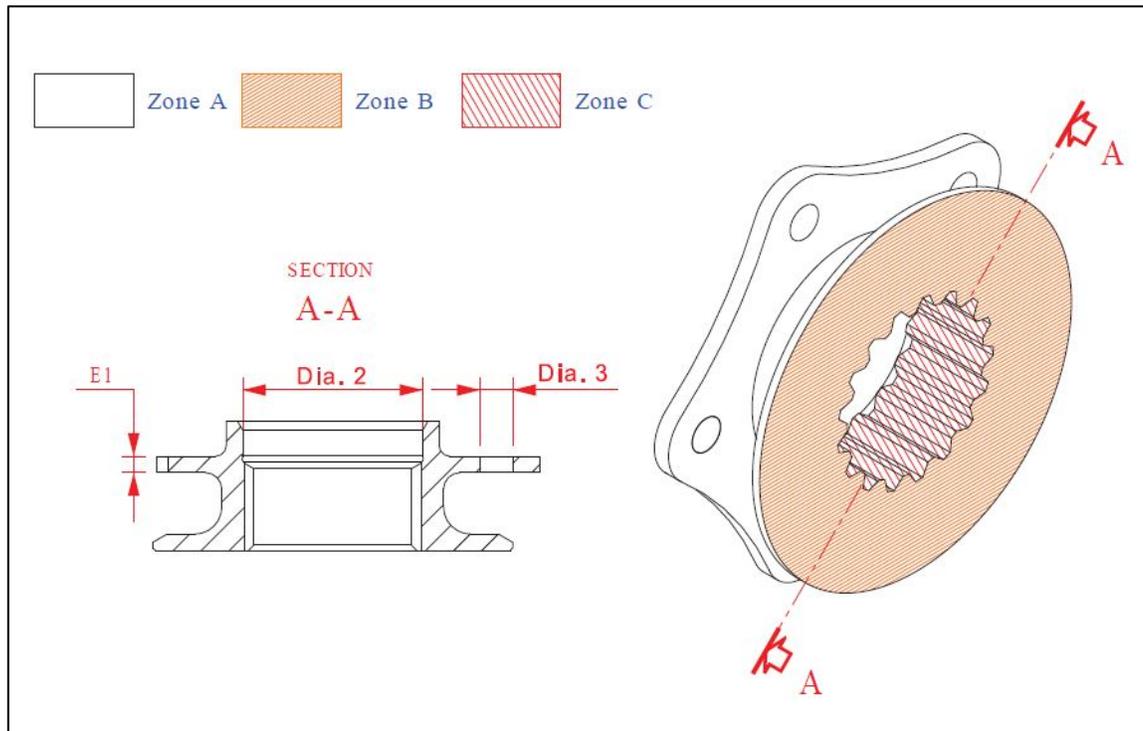
Figure 2 to paragraph (i)(1) – Inspection Areas of Tail Rotor Splined Flange

Location as specified in figure 2 to paragraph (i)(1) of this AD	Maximum damage, which causes replacement (E1, Dia. 2, and Dia. 3 are shown in figure 2 to paragraph (i)(1) of this AD)
Zone A	Score, depth more than 0.2 millimeters (mm) (0.008 in.) Crack E1 less than 2.75 mm (0.108 in.) Dia. 3 more than 6.02 mm (0.2371 in.) Dia. 2 more than 33.03 mm (1.3004 in.)
Zone B	Sanding depth more than 0.1 mm (0.004 in.) Crack
Zone C	Crack Score, depth more than 0.2 mm (0.008 in.)

(2) If, during any inspection of the tail rotor splined flange required by paragraph (i)(1) of this AD, the condition of the part exceeds the criteria as specified in figure 1 to paragraph (i)(1) of this AD, before next flight, replace the tail rotor splined flange with an airworthy tail rotor splined flange in accordance with the instructions of section 3.B.4 of Airbus Helicopters Emergency Alert Service Bulletin 05A020, Revision 1, dated November 8, 2019.
