**FEDERAL AVIATION ADMINISTRATION
AIRWORTHINESS DIRECTIVES**

**LARGE AIRCRAFT
BIWEEKLY 2014-05**

2/24/2014 - 3/9/2014

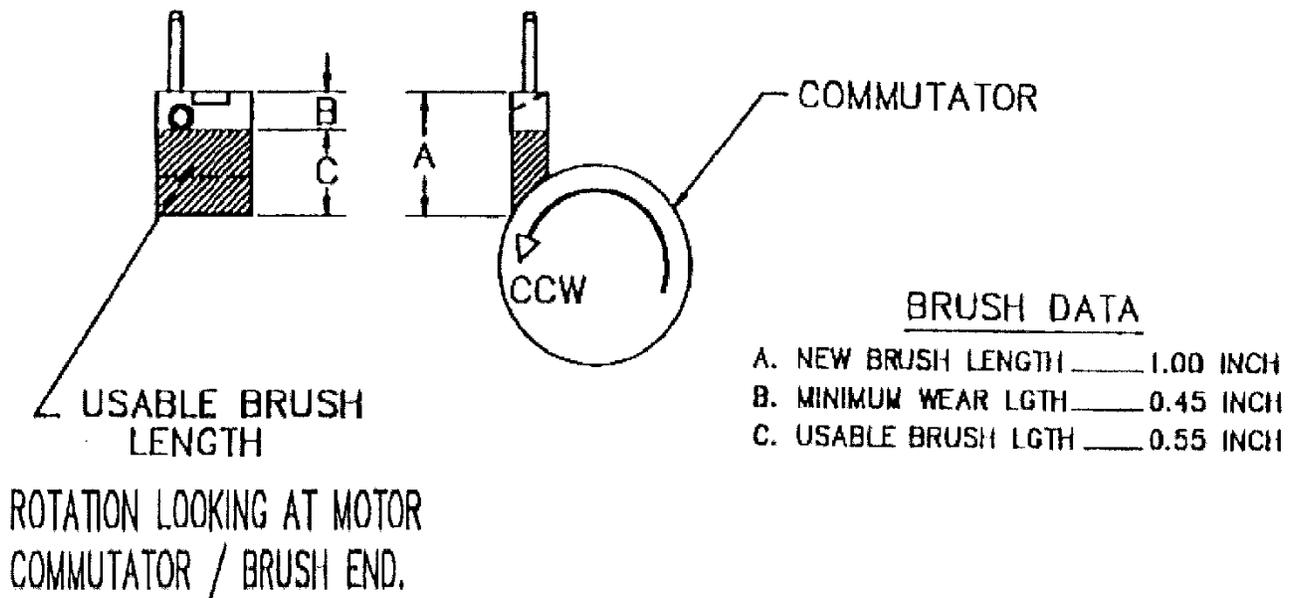
Figure 1 to paragraph (m)(4)(vii) of this AD – Measuring the Brush

- (vi) Lift brush spring and remove brush with wire hook or scribe.
 - (vii) Measure each brush as shown in figure below and record values.

(viii) Using the brush with the shortest measured length, calculate the wear by subtracting the measured value from 1.000 inch.

(ix) Replace brushes in accordance with the instructions specified in paragraphs (j)(9) through (j)(23) of this AD.
