**FEDERAL AVIATION ADMINISTRATION  
AIRWORTHINESS DIRECTIVES**

**BIWEEKLY 2014-07**

**2014-05-10 Airbus Helicopters (Type Certificate Previously Held By Eurocopter France):**  
Amendment 39-17783; Docket No. FAA-2013-0822; Directorate Identifier 2013-SW-004-AD.

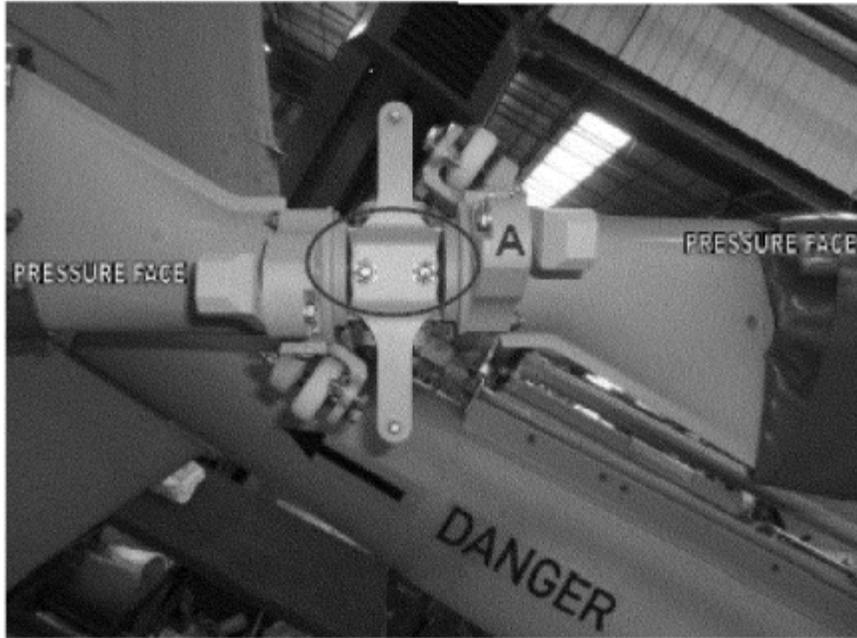
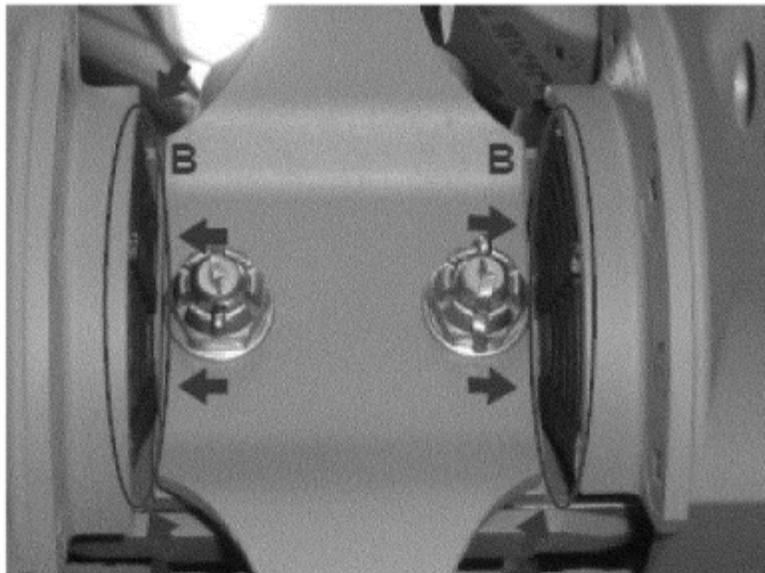
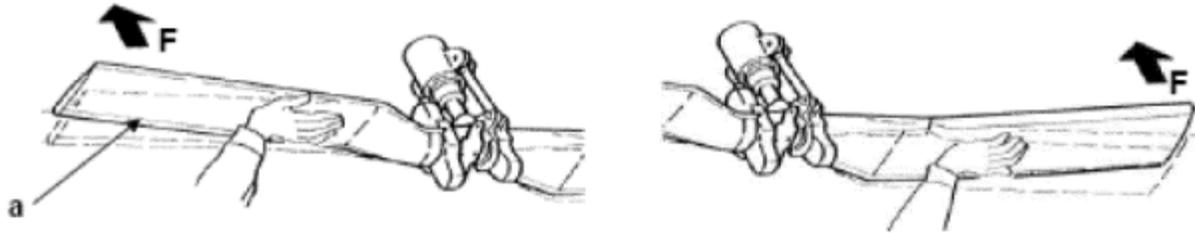
(C) While maintaining the load, check all the visible faces of the bearings (front and side faces) in area B of DETAIL A of Figure 3 to paragraph (f) of this AD for separation between the elastomer and metal parts, a crack in the elastomer, or an extrusion (see example in Figure 4 to paragraph (f) of this AD). A flashlight may be used to enhance the check.

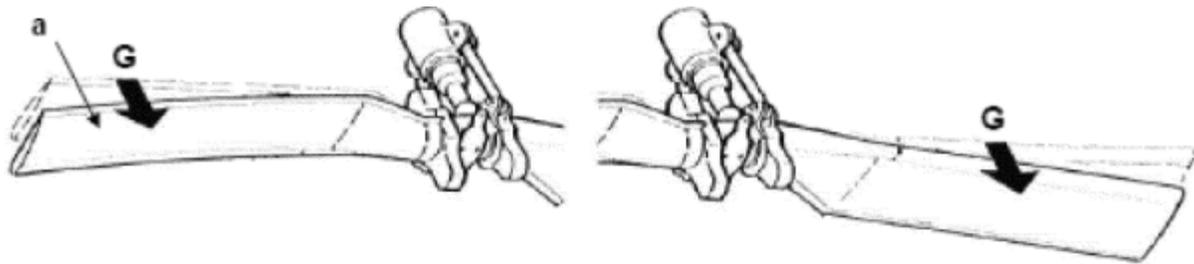
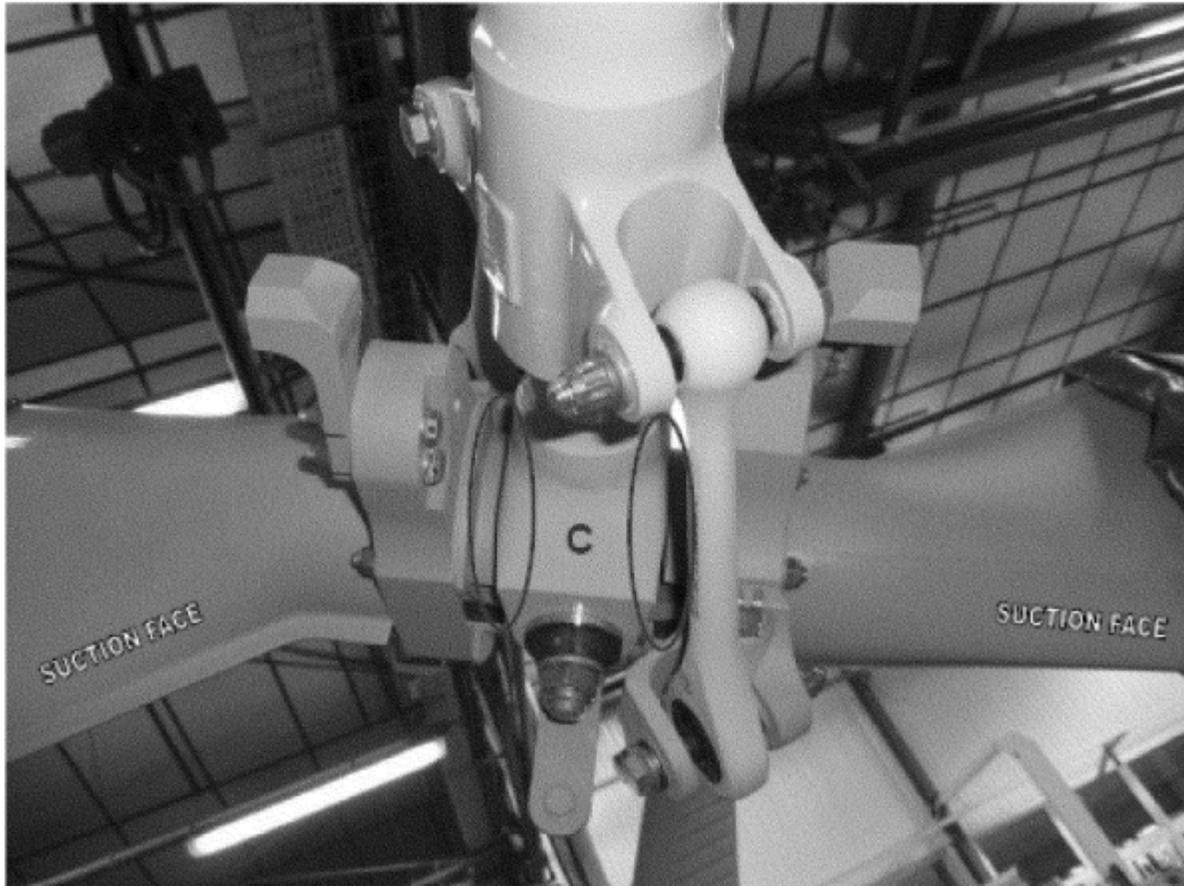
(F) While maintaining the load, check visible faces of Area C as shown in Figure 5 to paragraph (f) of this AD for any extrusion. A flashlight may be used to enhance the check.

(v) If there is an extrusion on any bearing, before further flight, replace the four bearings with airworthy bearings.

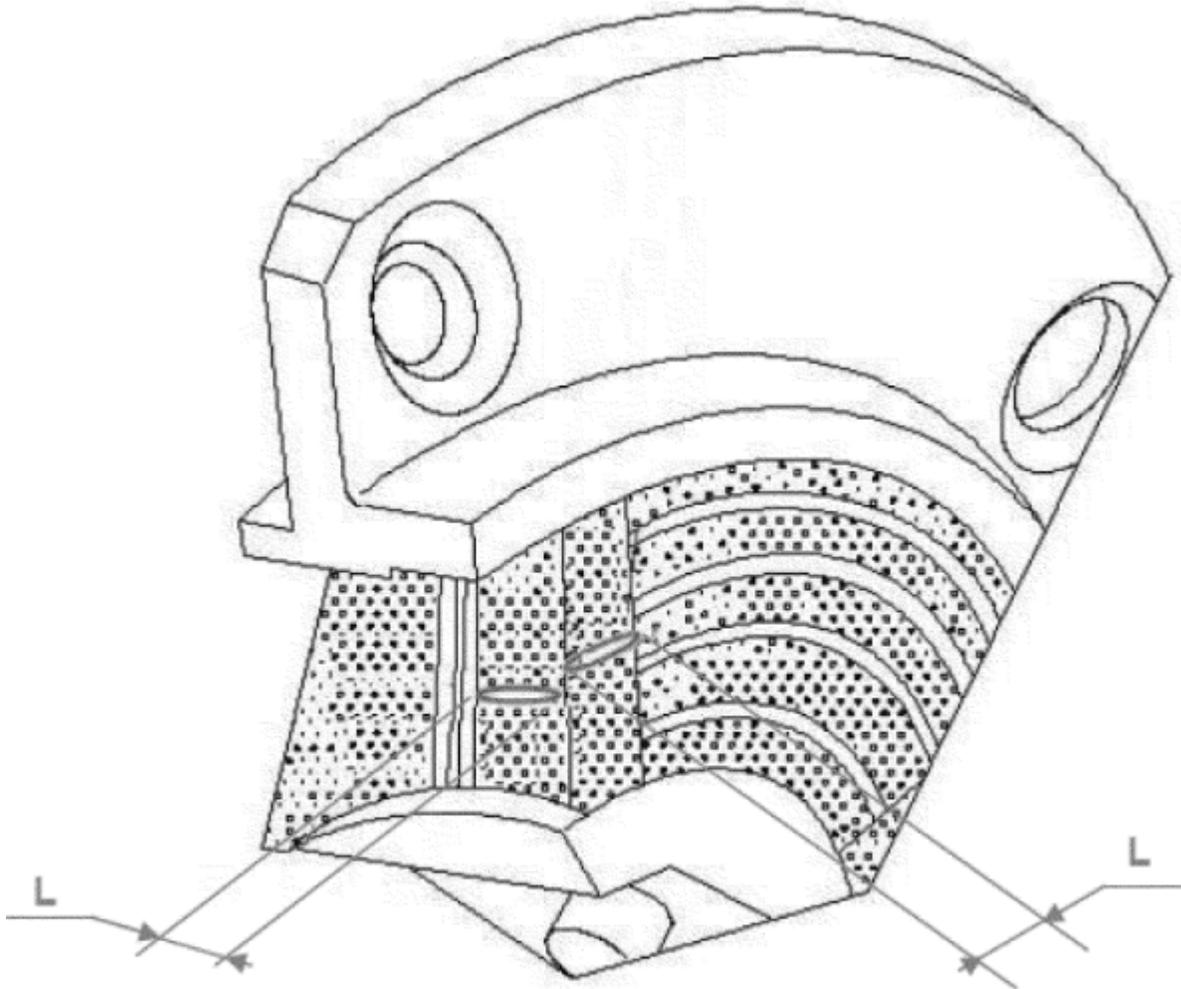
(vi) If there is a separation or a crack on the pressure side bearing, measure the separation or the crack. If the separation or crack is greater than 5 millimeters (.196 inches) as indicated by dimension "L" in Figure 6 to paragraph (f) of this AD, before further flight, replace the four bearings with airworthy bearings.
