Subject: Alternative Method of Compliance (AMOC) to AD2008-15-06 paragraph (e)(3)

**SUBJECT:** Addition of access holes to facilitate inspection called out in **SEB 07-2**, Engine Mount Bracket Inspection

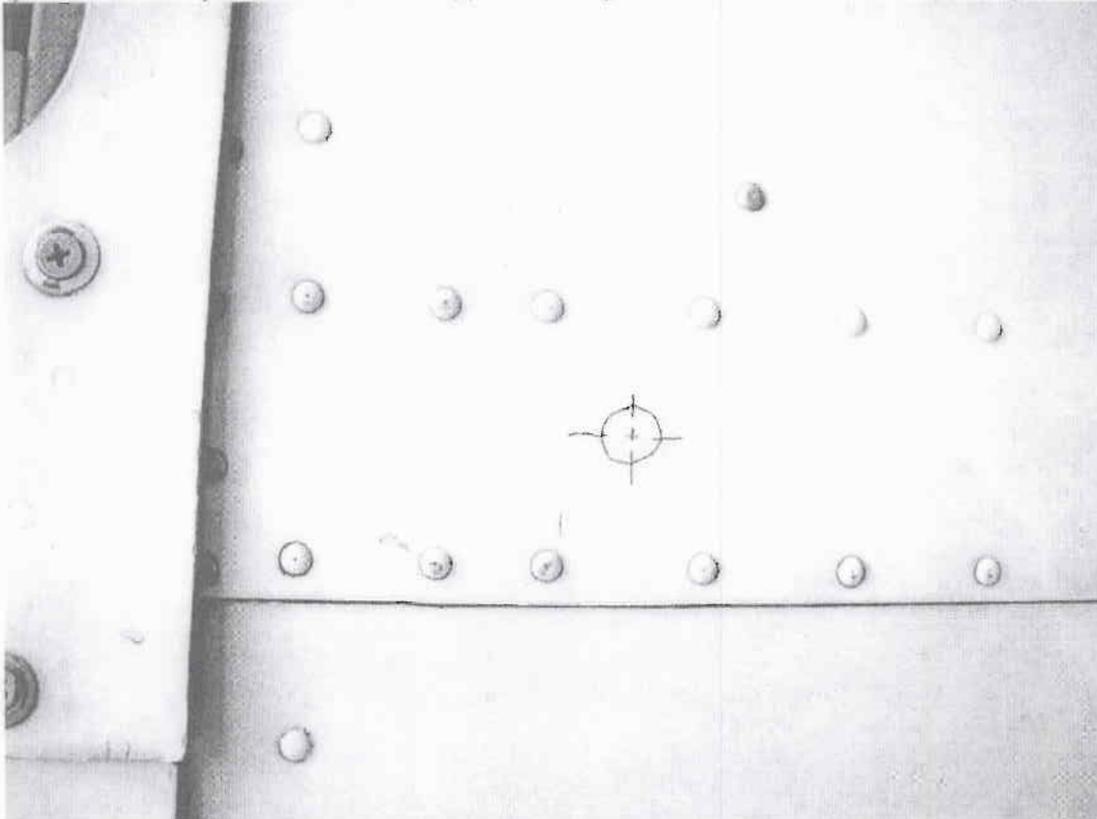
Photo 1: Upper left engine mount stringer

(p/n's under skin panel are 0513132-7 upper left stringer, shown, and 0513132-8 upper right stringer)

1. The added holes should be located midway between the two rivet lines that attach the longitudinal hat section stringer to the fuselage skin and between the 3rd and 4th rivet, in these rivet lines common to the skin lap, aft of the firewall. (see attached photos)

2. Remove any burrs and break all sharp edges after holes are drilled using a fine crocus cloth or equivalent.
3. To preclude corrosion: Apply brush alodine or a suitable epoxy primer to the hole I.D.

4. After inspection is complete, seal the hole to preclude entry of water, air or Carbon monoxide. A suitable plug button can be used if sealed with RTV (or equivalent) to prevent leakage or loss due to vibration. A circular patch of aircraft fabric could also be cemented to the skin to cover the added hole and seal it from any leaks.

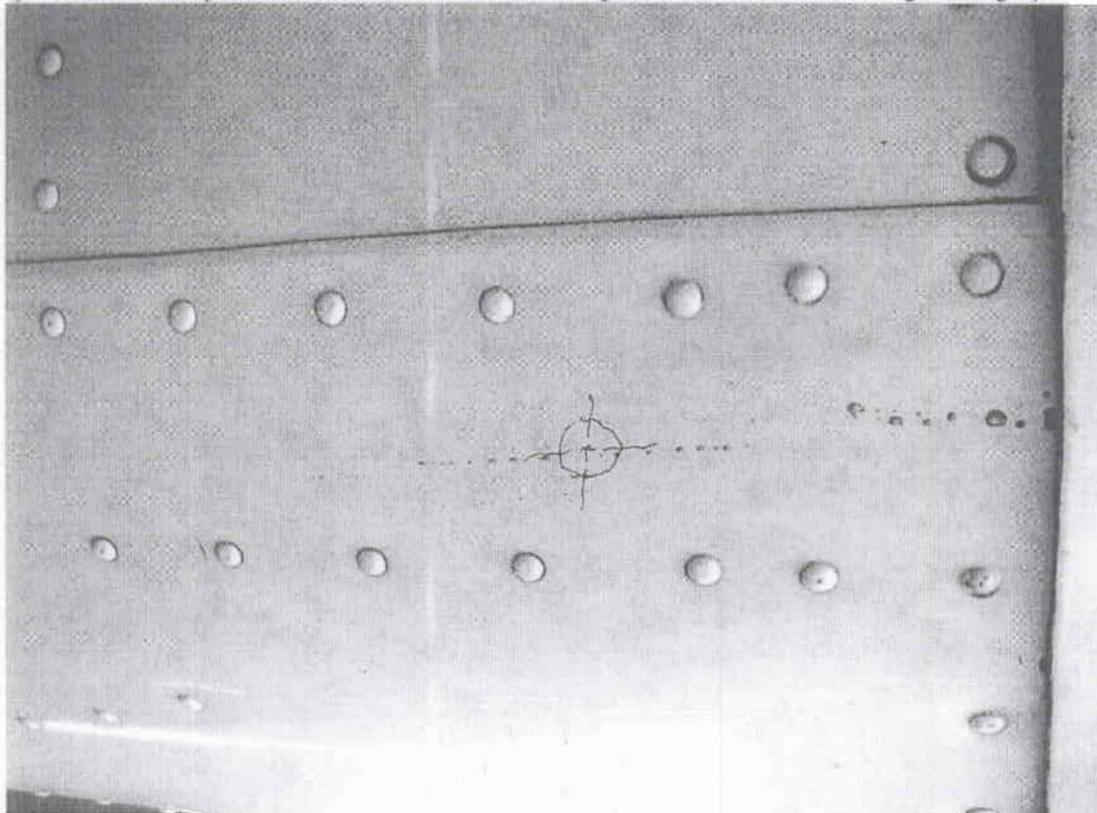
Photo 2: Lower left engine mount stringer

(p/n's under skin panel are 0513132-5 lower left stringer and 0513132-6 lower right stringer)
