**FEDERAL AVIATION ADMINISTRATION
AIRWORTHINESS DIRECTIVES**

**SMALL AIRCRAFT
ROTORCRAFT, GLIDERS, BALLOONS, AND AIRSHIPS
BIWEEKLY 2010-22**

October 26, 2010

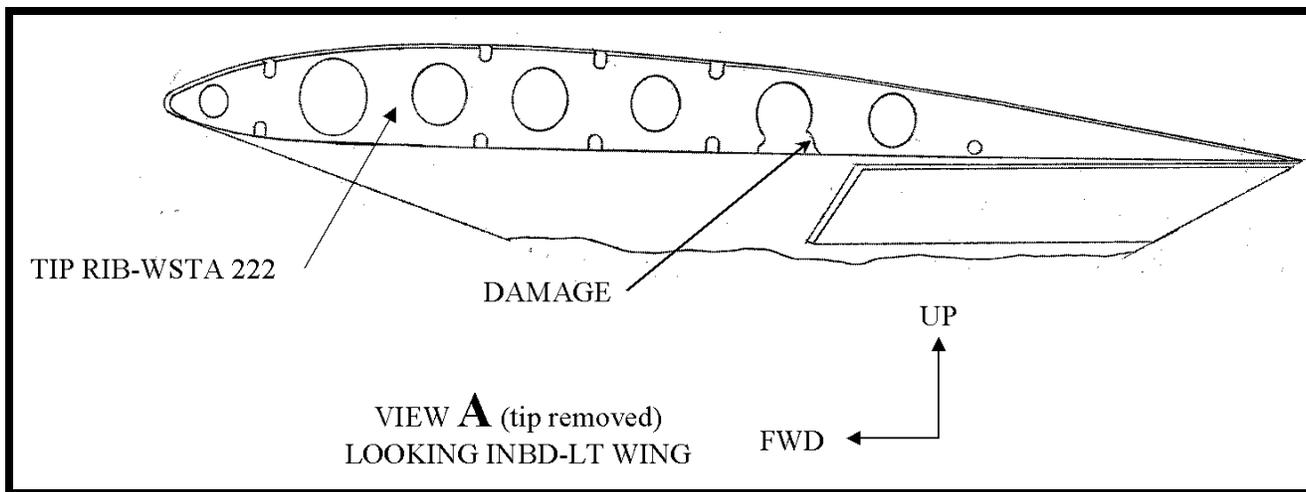
Figure 2

- (10) Inter-rivet buckling of the stringers attached to the upper surface skin, outboard of the fuel tank access covers (See View F, Figure 7).
- (11) Inspect rib at WSTA 222 for damage. Trimming of the rib may have been done to allow installation of fuel lines (See View A, Figure 2). Repair in accordance with AC 43.13-1B, Chapter 4, paragraph 4-58(g) and Figure 4-14, or by using another FAA-approved method that restores equivalent strength of the wing rib.

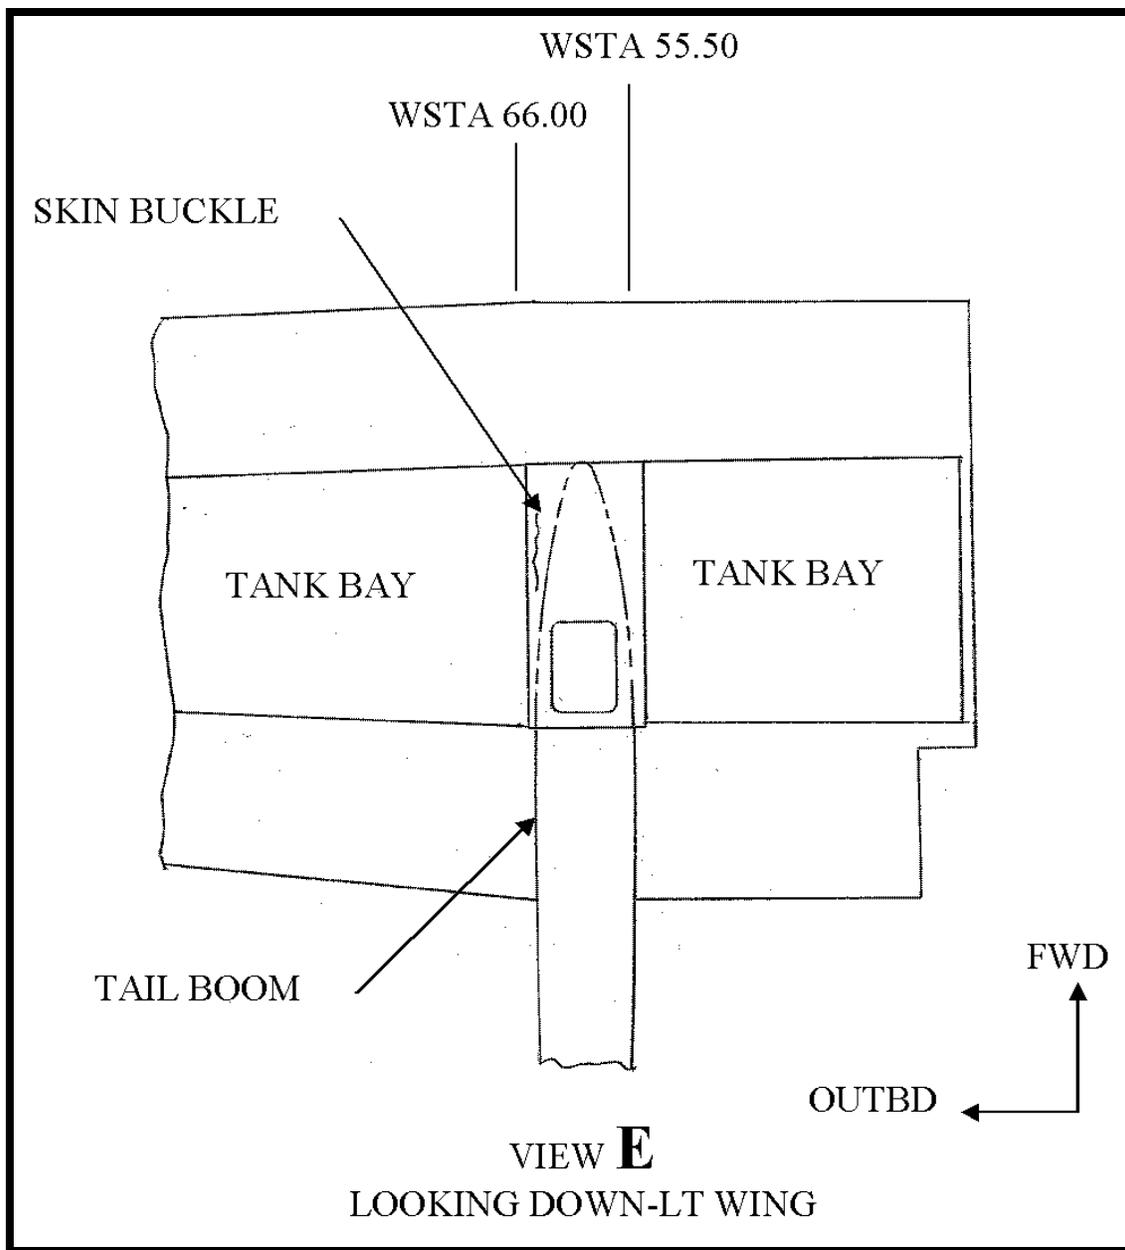
Figure 6

- (1) Wrinkles in upper wing skins, from the outboard edge on the fuel tank access covers (WSTA 150 or 177) to the WSTA 222 (See View B, Figure 3).
- (2) Wrinkles in the upper wing skins from WSTA 55 to 66, adjacent to the booms (See View E, Figure 6).
