**FEDERAL AVIATION ADMINISTRATION  
AIRWORTHINESS DIRECTIVES  
SMALL AIRCRAFT, ROTORCRAFT, GLIDERS,  
BALLOONS, & AIRSHIPS**

**BIWEEKLY 2011-18**

**Biweekly 2011-18**

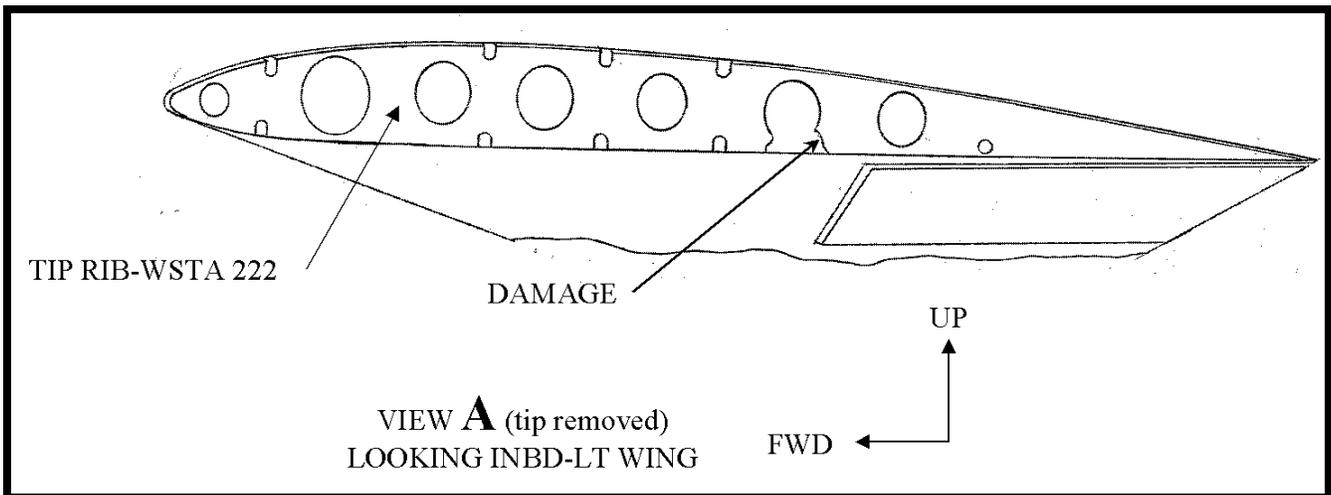
Figure 2

- (10) Inter-rivet buckling of the stringers attached to the upper surface skin, outboard of the fuel tank access covers (See View F, Figure 7).
- (11) Inspect rib at WSTA 222 for damage. Trimming of the rib may have been done to allow installation of fuel lines (See View A, Figure 2). Repair in accordance with AC 43.13-1B, Chapter 4, paragraph 4-58(g) and Figure 4-14, or by using another FAA-approved method that restores equivalent strength of the wing rib.

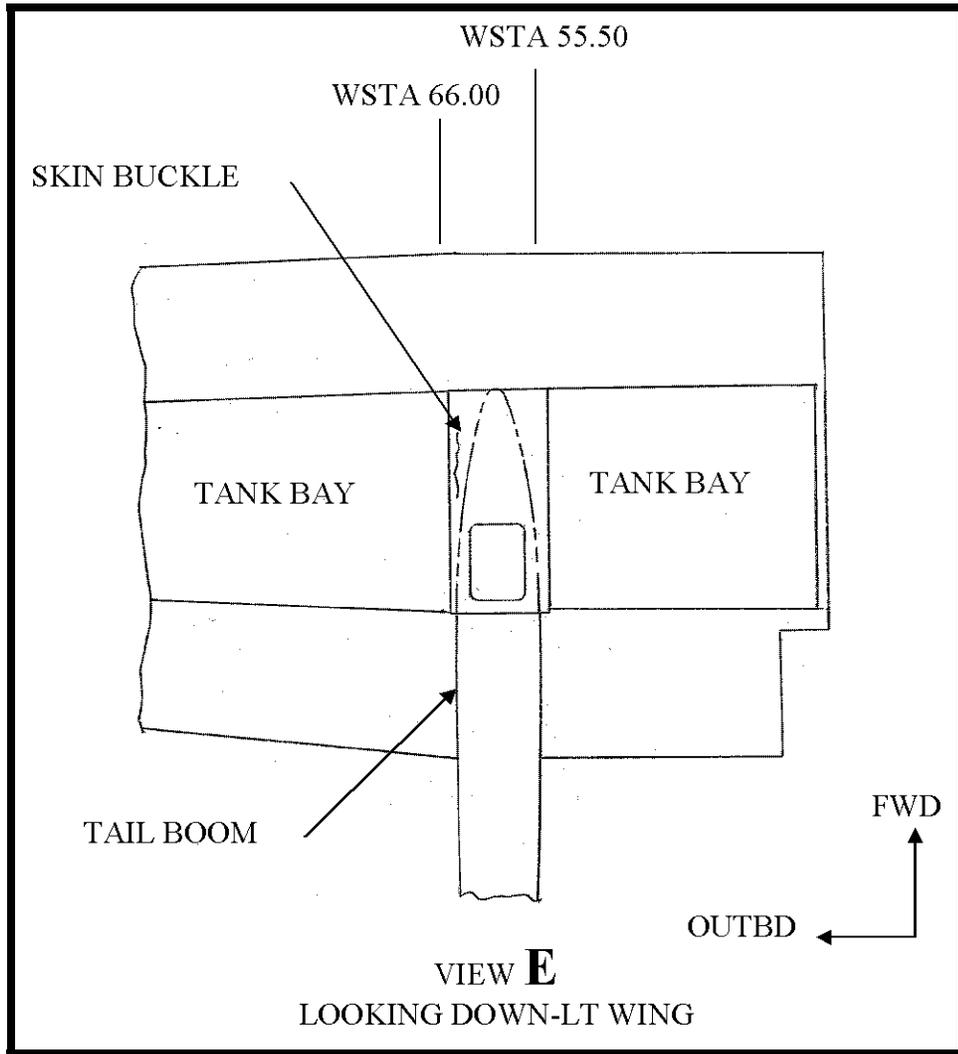
Figure 6

- (1) Wrinkles in upper wing skins, from the outboard edge on the fuel tank access covers (WSTA 150 or 177) to the WSTA 222 (See View B, Figure 3).
- (2) Wrinkles in the upper wing skins from WSTA 55 to 66, adjacent to the booms (See View E, Figure 6).
