**FEDERAL AVIATION ADMINISTRATION
AIRWORTHINESS DIRECTIVES**

**SMALL AIRPLANES, ROTORCRAFT, GLIDERS,
BALLOONS, & AIRSHIPS**

BIWEEKLY 2013-17

8/12/2013 - 8/25/2013

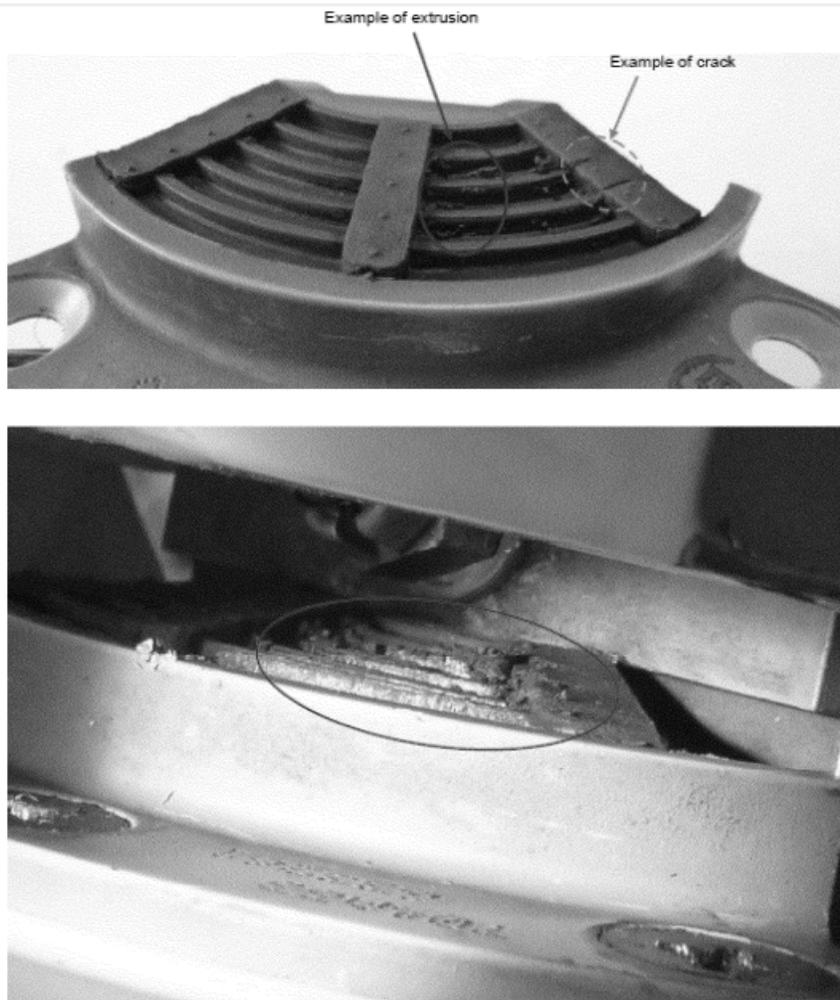
(iii) While maintaining the load, check all the visible faces of the bearings (front and side faces) in area B of DETAIL A of Figure 1 to paragraph (f) of this AD for separation between the elastomer and metal parts, a crack in the elastomer, or an extrusion (see example in Figure 2 to paragraph (f) of this AD). A flashlight may be used to enhance the check.

(5) If there is an extrusion on any bearing, before further flight, replace the four bearings with airworthy bearings.

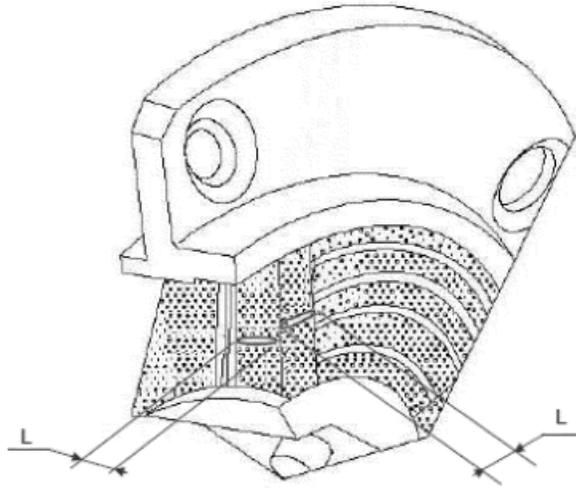
Figure 4 to paragraph (f)

(6) If there is a separation or a crack on the pressure side bearing, measure the separation or the crack. If the separation or crack is greater than 5 millimeters (.196 inches) as indicated by dimension "L" in Figure 4 to paragraph (f), before further flight, replace the four bearings with airworthy bearings.

(7) No later than after the last flight of the day, perform a one-time inspection by removing the bearings and inspecting for a separation, a crack, or an extrusion. This inspection is not a daily inspection. If there is a separation, crack, or extrusion, before further flight, replace the four bearings with airworthy bearings.
