**FEDERAL AVIATION ADMINISTRATION  
AIRWORTHINESS DIRECTIVES  
SMALL AIRCRAFT, ROTORCRAFT, GLIDERS,  
BALLOONS, & AIRSHIPS**

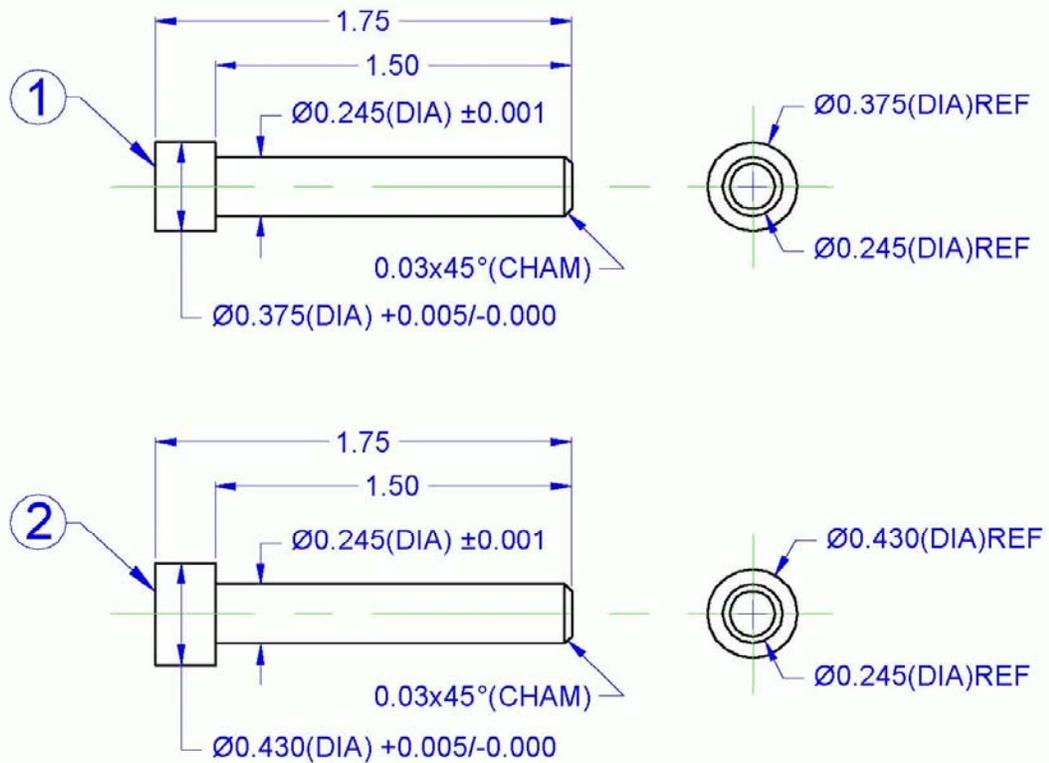
Figure 1

KEY	PART NO.	DESCRIPTION	SIZE	MATERIAL SPEC.	HEAT TREAT	NOTES
2	45-127-2	BUSHING TOOL	Ø0.44(DIA) x1.75	ALUMINUM		BREAK ALL SHARP EDGES
1	45-127-1	BUSHING TOOL	Ø0.38(DIA) x1.75	ALUMINUM		BREAK ALL SHARP EDGES

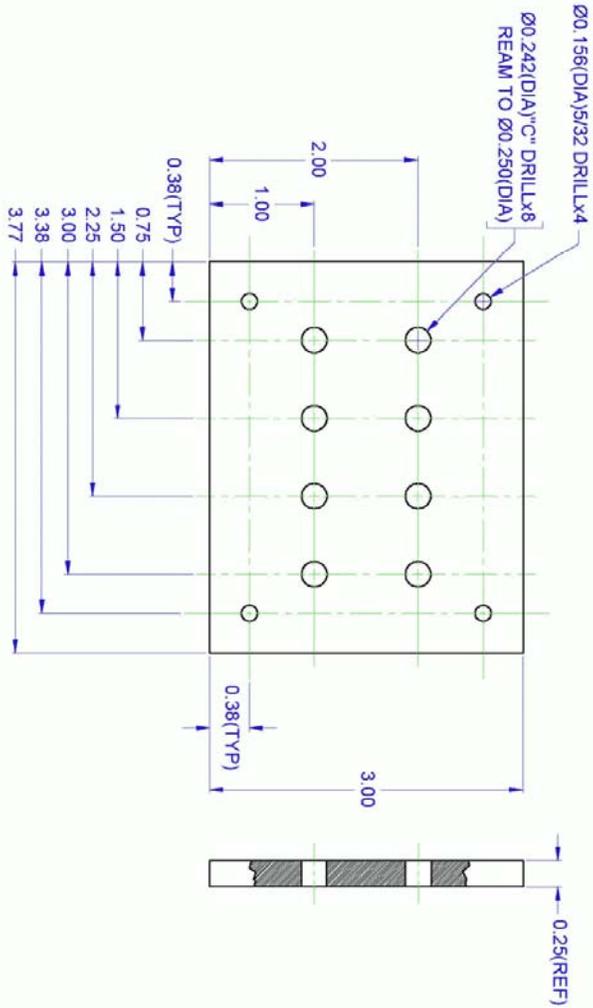
<b>PARTNO.</b>	45-128-2	<b>DESCRIPTION</b>	TEST COUPON	<b>SIZE</b>	3.00x3.77 #0.25	<b>MATERIAL SPEC.</b>	MILD STEEL	<b>HEAT TREATMENT</b>		<b>NOTES</b>	BREAK ALL SHARP EDGES
<b>EXAMINATION AND TOLERANCES TO WHICH THIS DRAWING IS REFERRED</b>	GENERAL AVIATION MODIFICATIONS, INC. 2000 W. WASHINGTON ST. OKLAHOMA CITY, OKLAHOMA 73102										
<b>DESIGNER</b>	LUKE KERR	<b>DATE</b>	3-22-05								
<b>APPROVED</b>		<b>DATE</b>									
<b>CONVENTIONS AND SYMBOLS REFERRED TO IN THIS DRAWING</b>	COUPON 45-128-2 SHEET 1 OF 4
