**FEDERAL AVIATION ADMINISTRATION  
AIRWORTHINESS DIRECTIVES  
SMALL AIRCRAFT, ROTORCRAFT, GLIDERS,  
BALLOONS, & AIRSHIPS**

**BIWEEKLY 2012-08**

**SMALL AIRCRAFT, ROTORCRAFT, GLIDERS, BALLOONS, & AIRSHIPS**

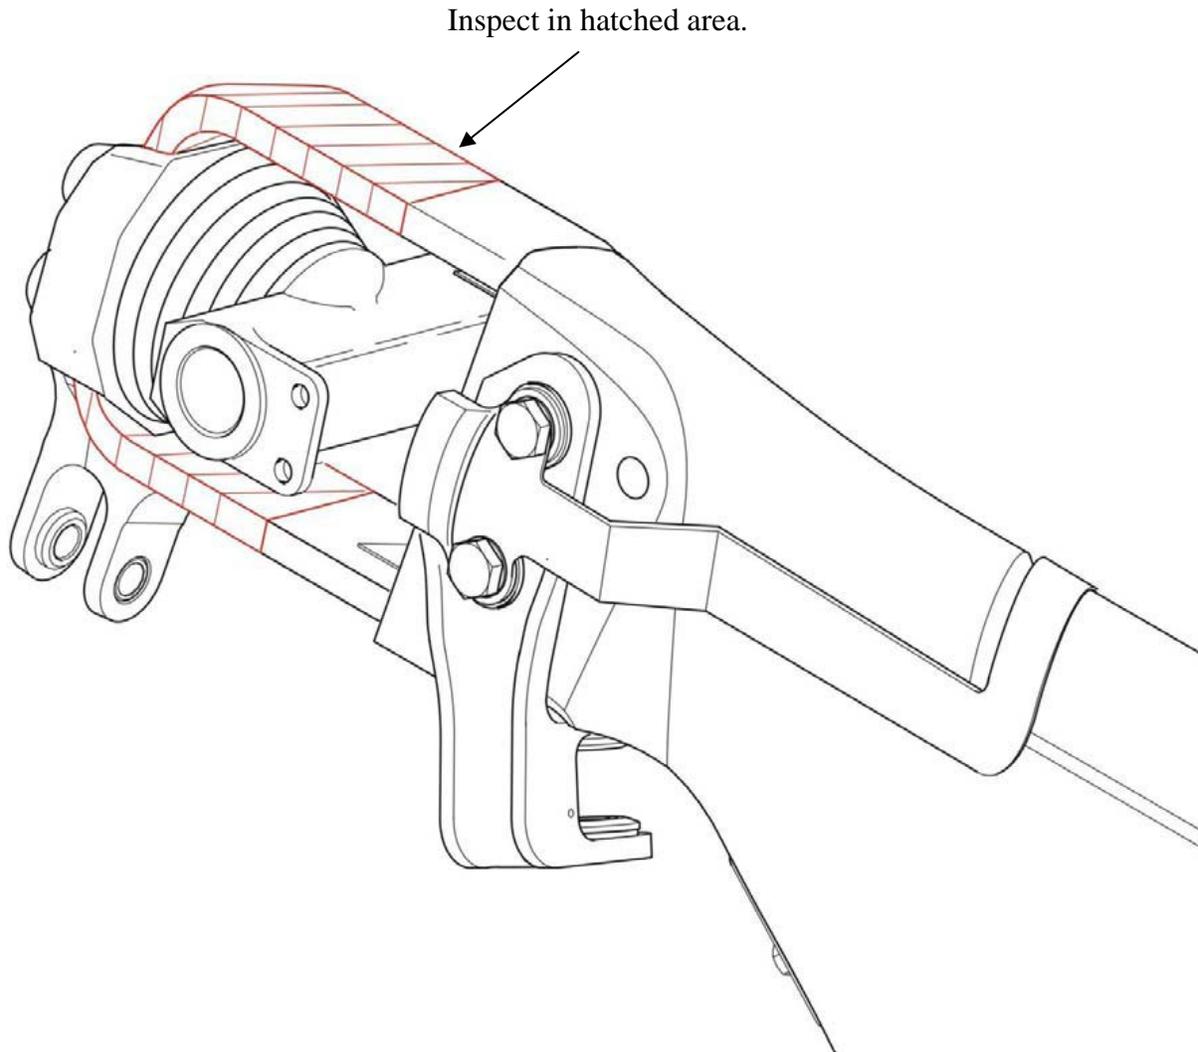
(3) Within 25 hours TIS, and thereafter at intervals not to exceed 25 hours TIS, visually inspect the T/R blade for a crack or damage that exceeds the limits of the applicable maintenance manual. Inspect in the area depicted in the following figure using a mirror, magnifying glass (5X or greater), and light source, or borescope.

This AD defines the unsafe condition as cracks in a T/R blade. The actions in this AD are intended to detect and prevent a crack in a T/R blade which could lead to failure of a T/R blade and subsequent loss of control of the helicopter.

(4) If there is a crack, or if there is damage that exceeds the limits of the applicable maintenance manual, before further flight, replace the T/R blade with an airworthy T/R blade.
