Federal Aviation Administration

Memorandum

Subject: Equivalent Level of Safety (ELOS) Finding for SyberJet Aircraft Avionics System Upgrade on Model SJ30-2ASV, FAA Project # AT2244AC-A

ELOS Memo#: ACE-05-16A

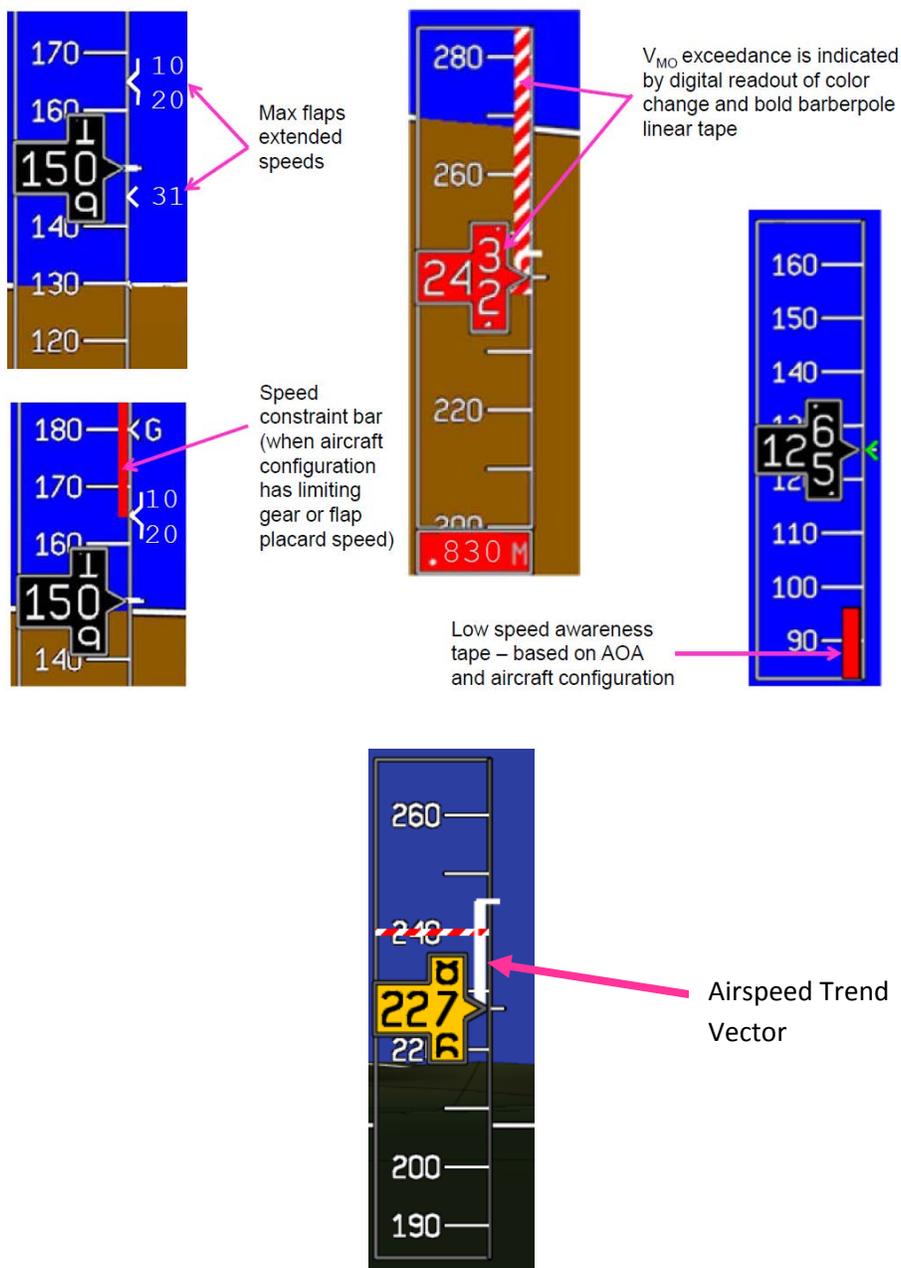
The Model SJ30-2ASV incorporates electronic flight displays and utilizes a linear tape airspeed indication on the left side of the Primary Flight Display, as shown in Figure 1. Advisory Circular (AC) 23.1311-1C, Installation of Electronic Display in part 23 Airplanes, paragraph

¹ All airspeed values are generic and may not represent the airspeed limitations of the SJ30-2ASV

Figure 1 – Examples of airspeed awareness cues on the SJ30-2ASV Primus Apex™ system¹

In accordance with guidance provided in AC 23.1311-1C, the linear airspeed tape indicator includes airspeed awareness cues equivalent or superior to cues provided by traditional round dial type indicators. Figure 1 above provides examples of the airspeed awareness cues provided by the SJ30-2ASV Primus Apex™ system.

bugs as shown in Table 1 below (see Fig. 1 for an example of the actual appearance on the airspeed tape):

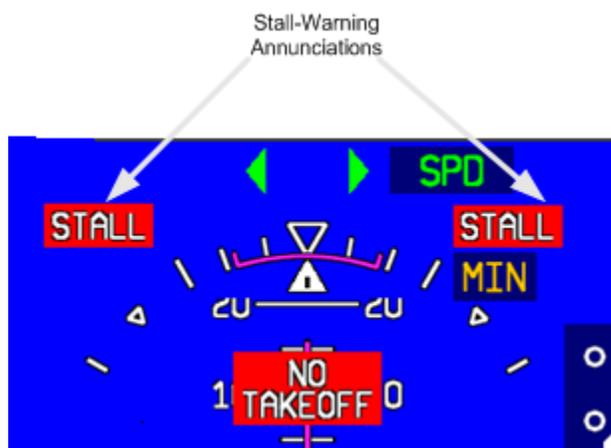
Figure 2. Stall Warning Annunciators

- “STALL” and “OVERSPEED” annunciations displayed on the ADI section of the PFD to alert the pilot of an imminent stall or speed exceedance condition.
- When a stall is imminent, two annunciators within the ADI will flash red reverse video on the ADI for 5 seconds, and then remain steady as show in Figure 2. Additionally a ‘Stall’ aural warning will be active for the duration of the stall condition.
- Color changes or emphasis of display elements (e.g. color change of digital airspeed readout)

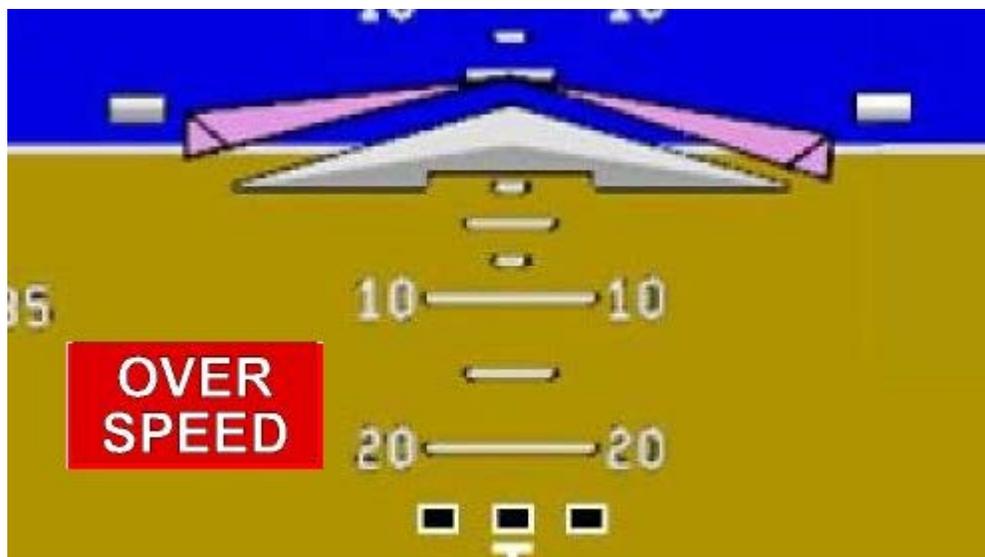
At any time, the Airspeed is greater than the V_{MO} or V constraint (gear or flaps), the Airspeed digits turn red, overspeed annunciation and aural warning are active. The annunciation is displayed in the ADI Flight Alert area as depicted in Figure 3. The CAB ALT, GEAR, OVERSPEED, and CAB PRESS alerts share the same display window on the PFD. The CAB ALT alert has the highest visual priority, followed by GEAR, OVERSPEED, and CAB PRESS.

Figure 3. Overspeed Warning Annunciator
