**Boeing Airplane Services**

**Regulatory Docket  
No. FAA-2000-8508**

**PARTIAL GRANT OF EXEMPTION**

ANM-01-093-E The requested exemption, if granted, would permit relief from the requirements of these regulations for the Boeing Model 757-200 series

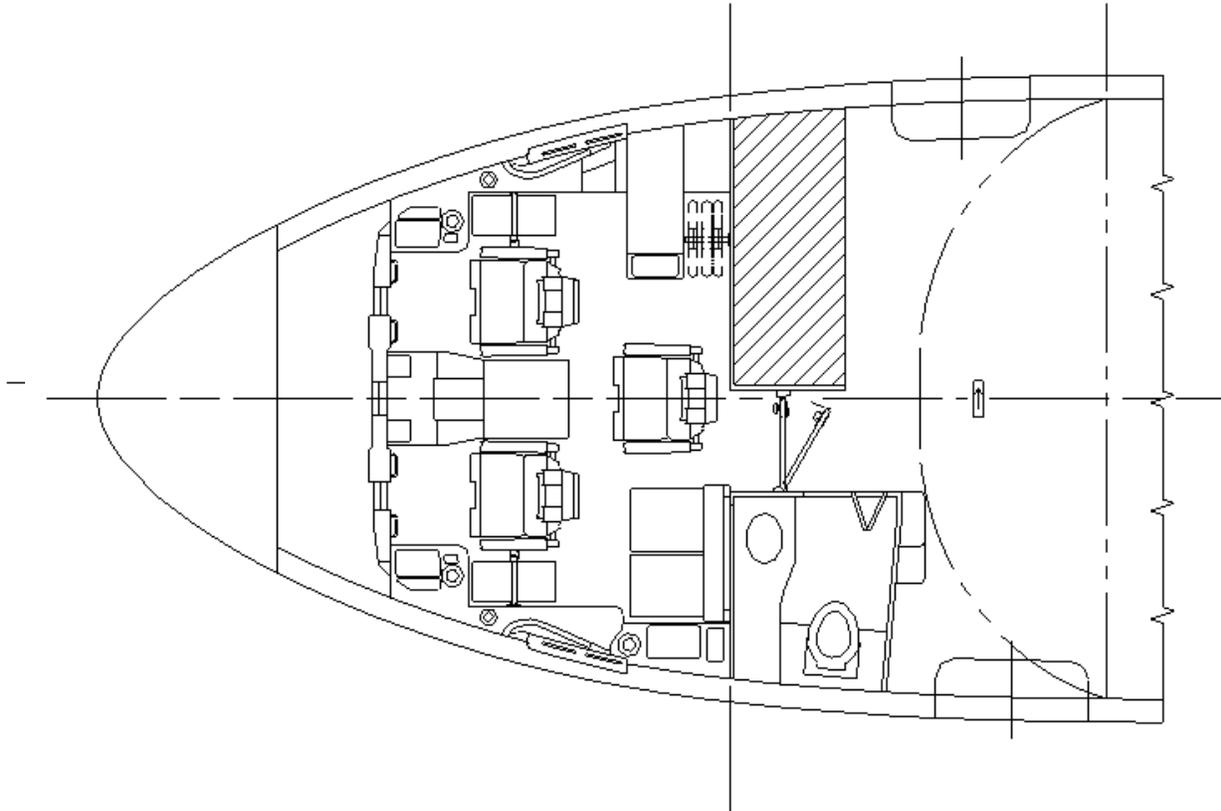
**757 Special Freighter  
Emergency Exit Arrangement**

**Attachment 1 to Petition Letter 3-J702-AC-00-066, Revisions 3 & 4:  
Egress Provisions for 757-200 Special Freighter with  
Five Person Maximum Occupancy**
