**FEDERAL AVIATION ADMINISTRATION  
AIRWORTHINESS DIRECTIVES**

**LARGE AIRCRAFT  
BIWEEKLY 2016-26**

*12/12/2016 - 12/25/2016*

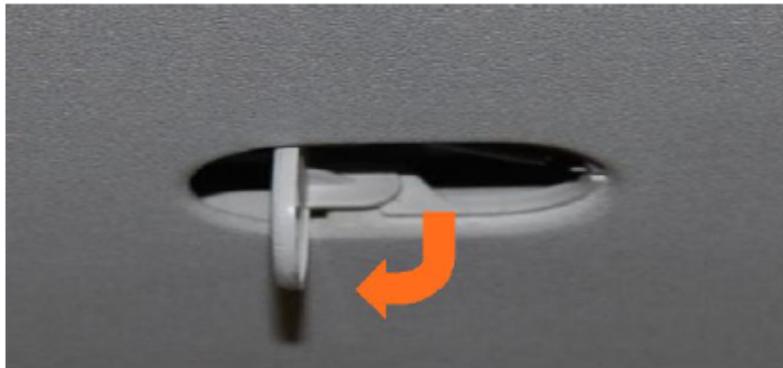
**Picture B:**

**Figure 1 to Paragraph (i)(7) of this AD – Design A of the Passenger Oxygen Containers Affected by this AD**

YY/YYYY : Month and Year of Inspection of Container  
 X : number of masks  
 ZZ : Oxygen mask code from the 7. + 8. place of the Customer Part No.

(7) The requirements of paragraphs (g) and (h) of this AD apply only to passenger oxygen containers that are Design A, as defined in figure 1 to paragraph (i)(7) of this AD.

Note 1 to figure 1 to paragraph (i)(7) of this AD: Figure 1 is a reproduction of material from EASA AD 2012-0083, dated May 16, 2012. The words "Appendix 1 of this AD" in this figure refer to Appendix 1 of EASA AD 2012-0083, dated May 16, 2012.

Note 2 to figure 1 to paragraph (i)(7) of this AD: For "Design A," the placard on the passenger oxygen container test button is as described in "Picture A" in figure 1 to paragraph (i)(7) of this AD.

(7) The requirements of paragraphs (k) and (l) of this AD apply only to passenger oxygen containers that are Design A, as defined in figure 1 to paragraph (i)(7) of this AD.
