**FEDERAL AVIATION ADMINISTRATION
AIRWORTHINESS DIRECTIVES**

**SMALL AIRPLANES, ROTORCRAFT, GLIDERS,
BALLOONS, & AIRSHIPS**

BIWEEKLY 2015-03

1/26/2015 - 2/8/2015

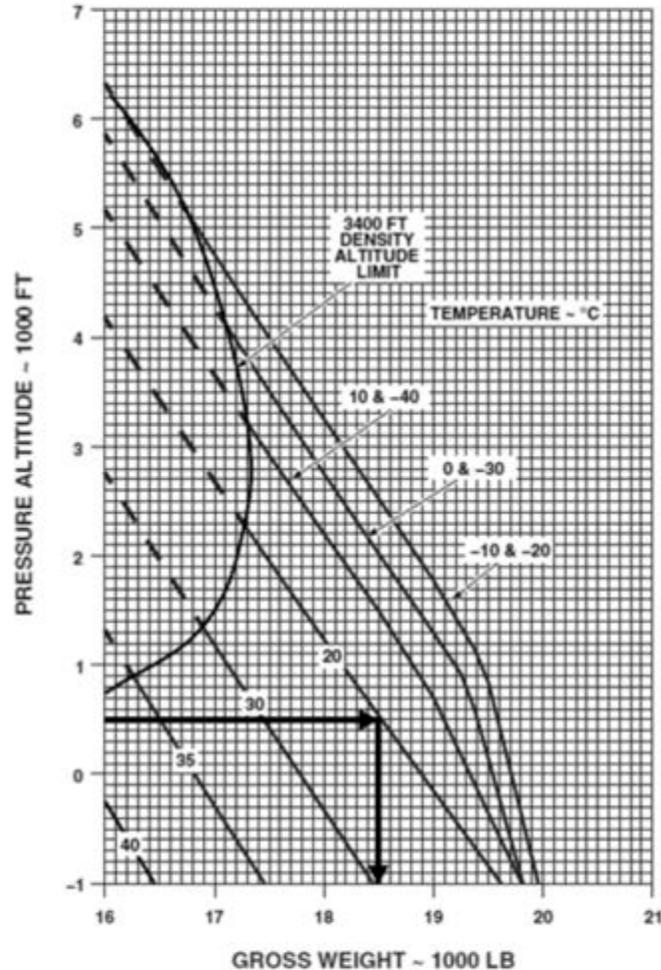
**S-92A MAXIMUM GROSS WEIGHT
FOR HOISTING HUMAN EXTERNAL CARGO
REQUIRING CATEGORY A**

ONE ENGINE INOPERATIVE OEI 30 SECOND POWER
AIR-CONDITIONER OFF ANTI-ICE OFF BLEED AIR OFF

NOTE 1: THIS CHART DEPICTS THE GROSS WEIGHT, PRESSURE ALTITUDE, TEMPERATURE COMBINATION WHERE OEI HOGE CAPABILITY EXISTS USING 30 SECOND OEI POWER WITH A 60 SHP MARGIN.

NOTE 2: 15 FT OF GROUND CLEARANCE IS ASSURED IN THE EVENT OF AN ENGINE FAILURE AT 20 TO 80 FT AGL.

(ii) Add the following: "NOTE: If conditions permit, the pilot may go to the right of the 26,500 pound line on Figure 1-2 to determine the maximum gross weight and then subtract a 150 pound hoist decrement. The maximum gross weight for category 'A' operations cannot exceed 26,500 pounds (12,020 kilograms)."

" "HOIST" Maximum gross weight for Human External Cargo, which requires category 'A' performance capabilities, is limited to the gross weight determined in accordance with the following Figure 1 to Paragraph (f)(3)(iii) of this AD for your altitude and temperature with the air-conditioner, anti-ice, and bleed air turned off."
